# Historic Woolsey Church

Resurrecting a local landmark

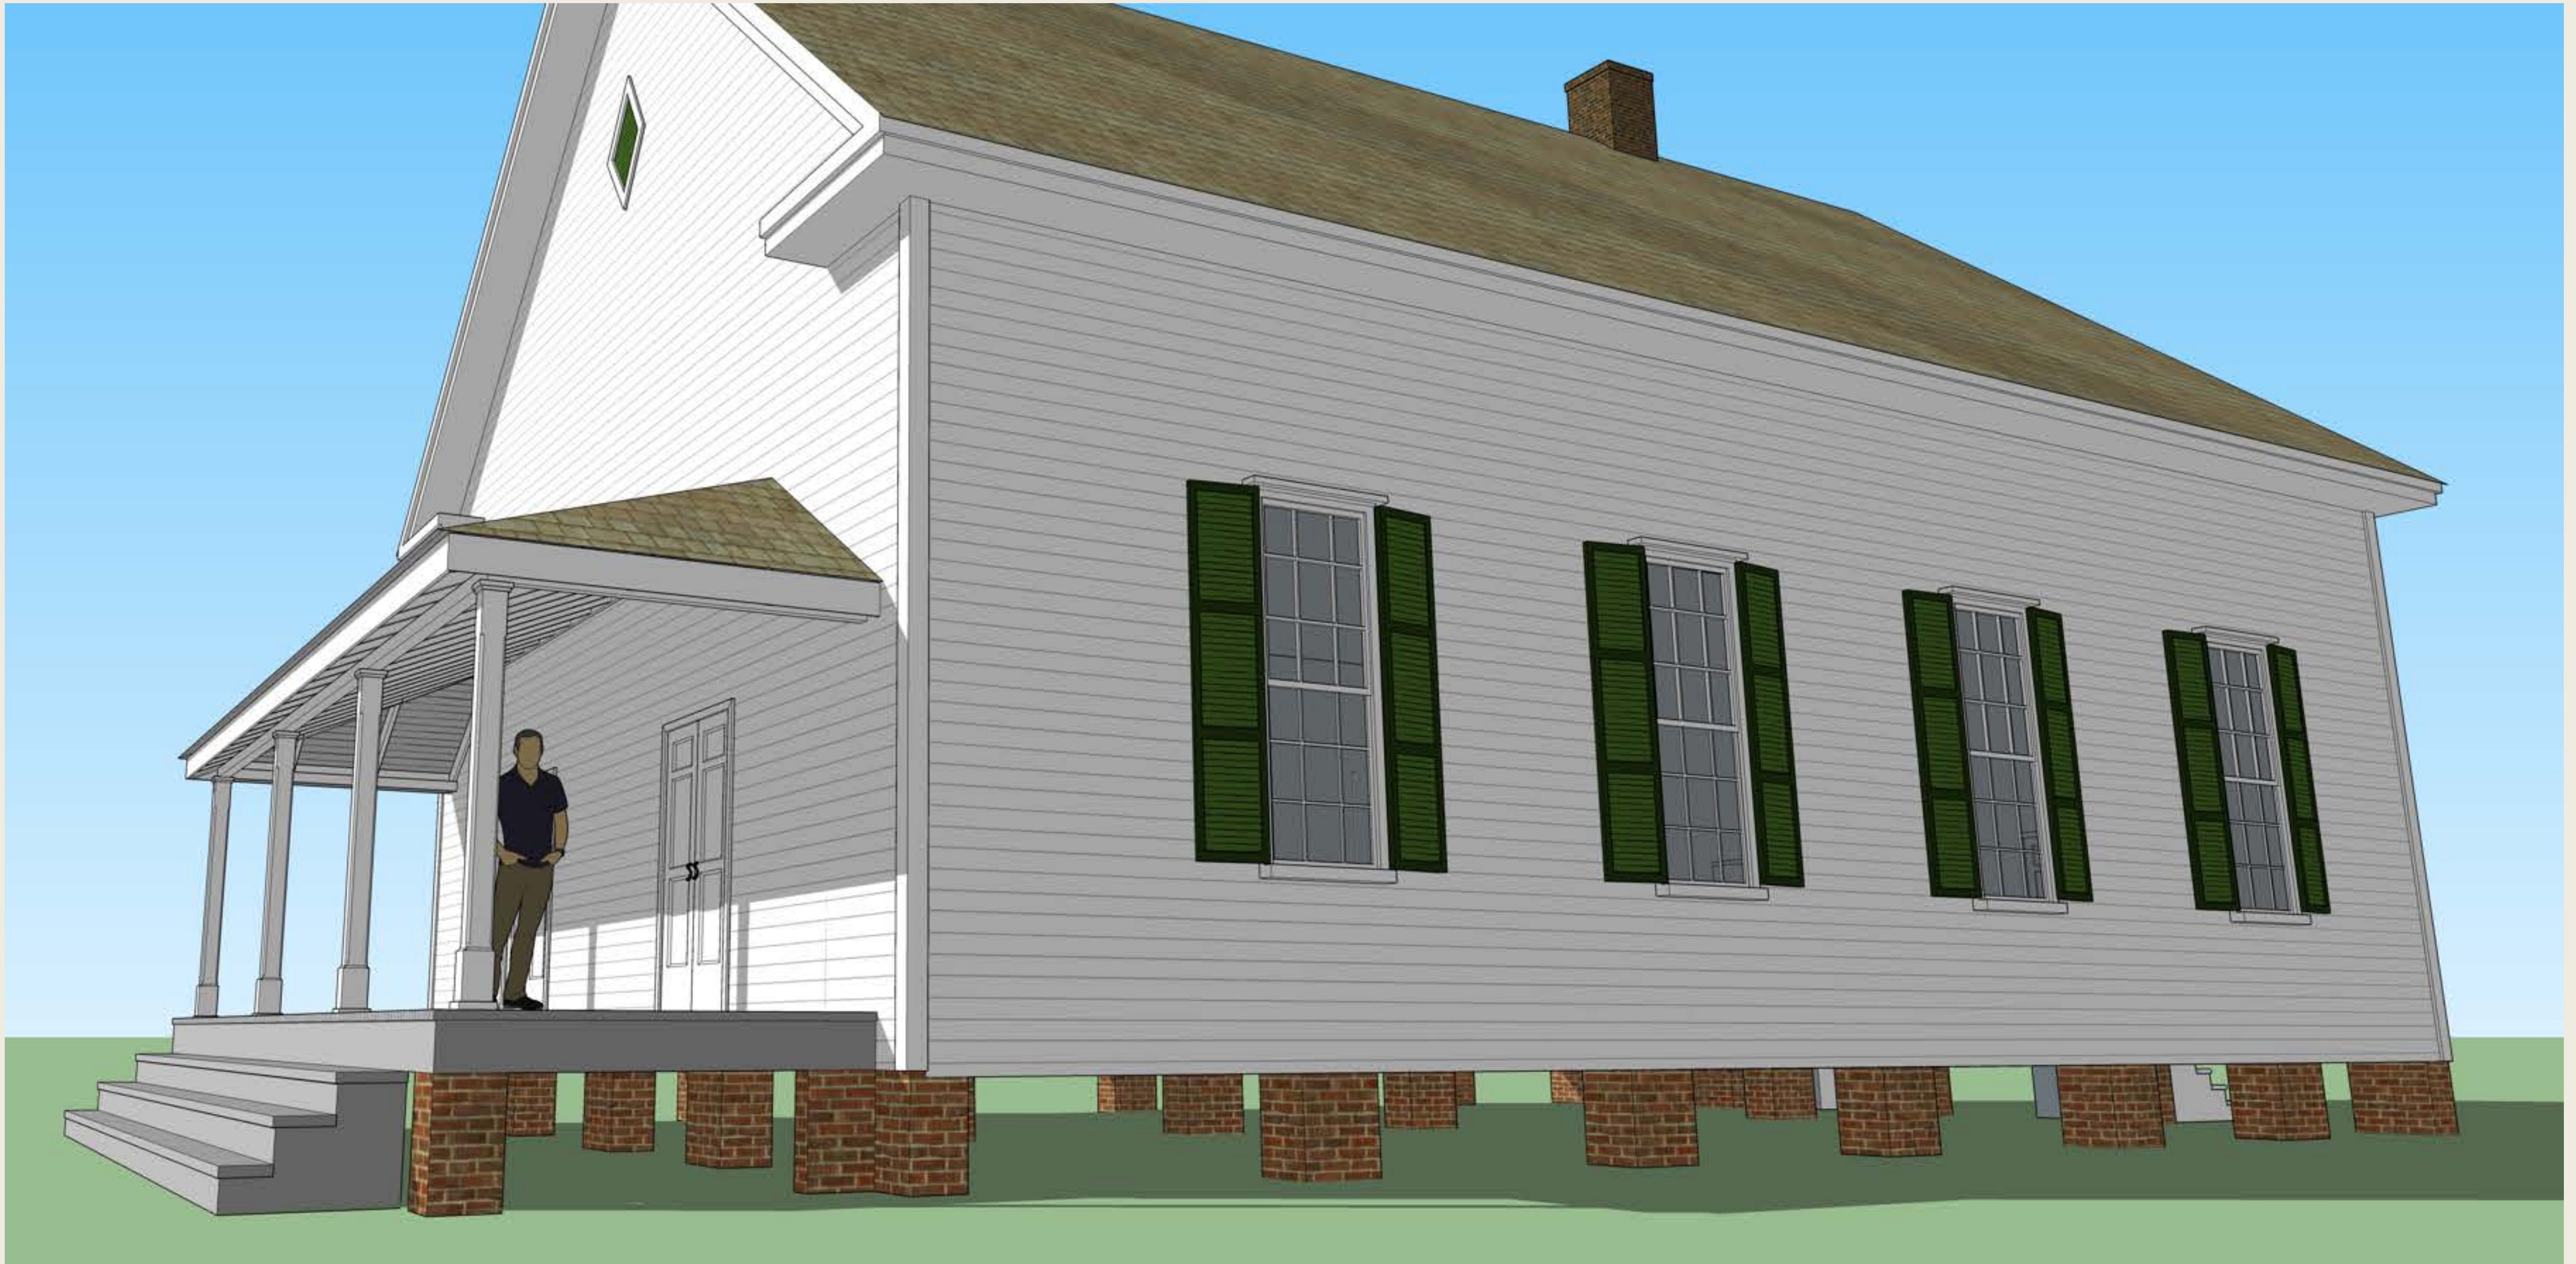
Proposed porch reconstruction

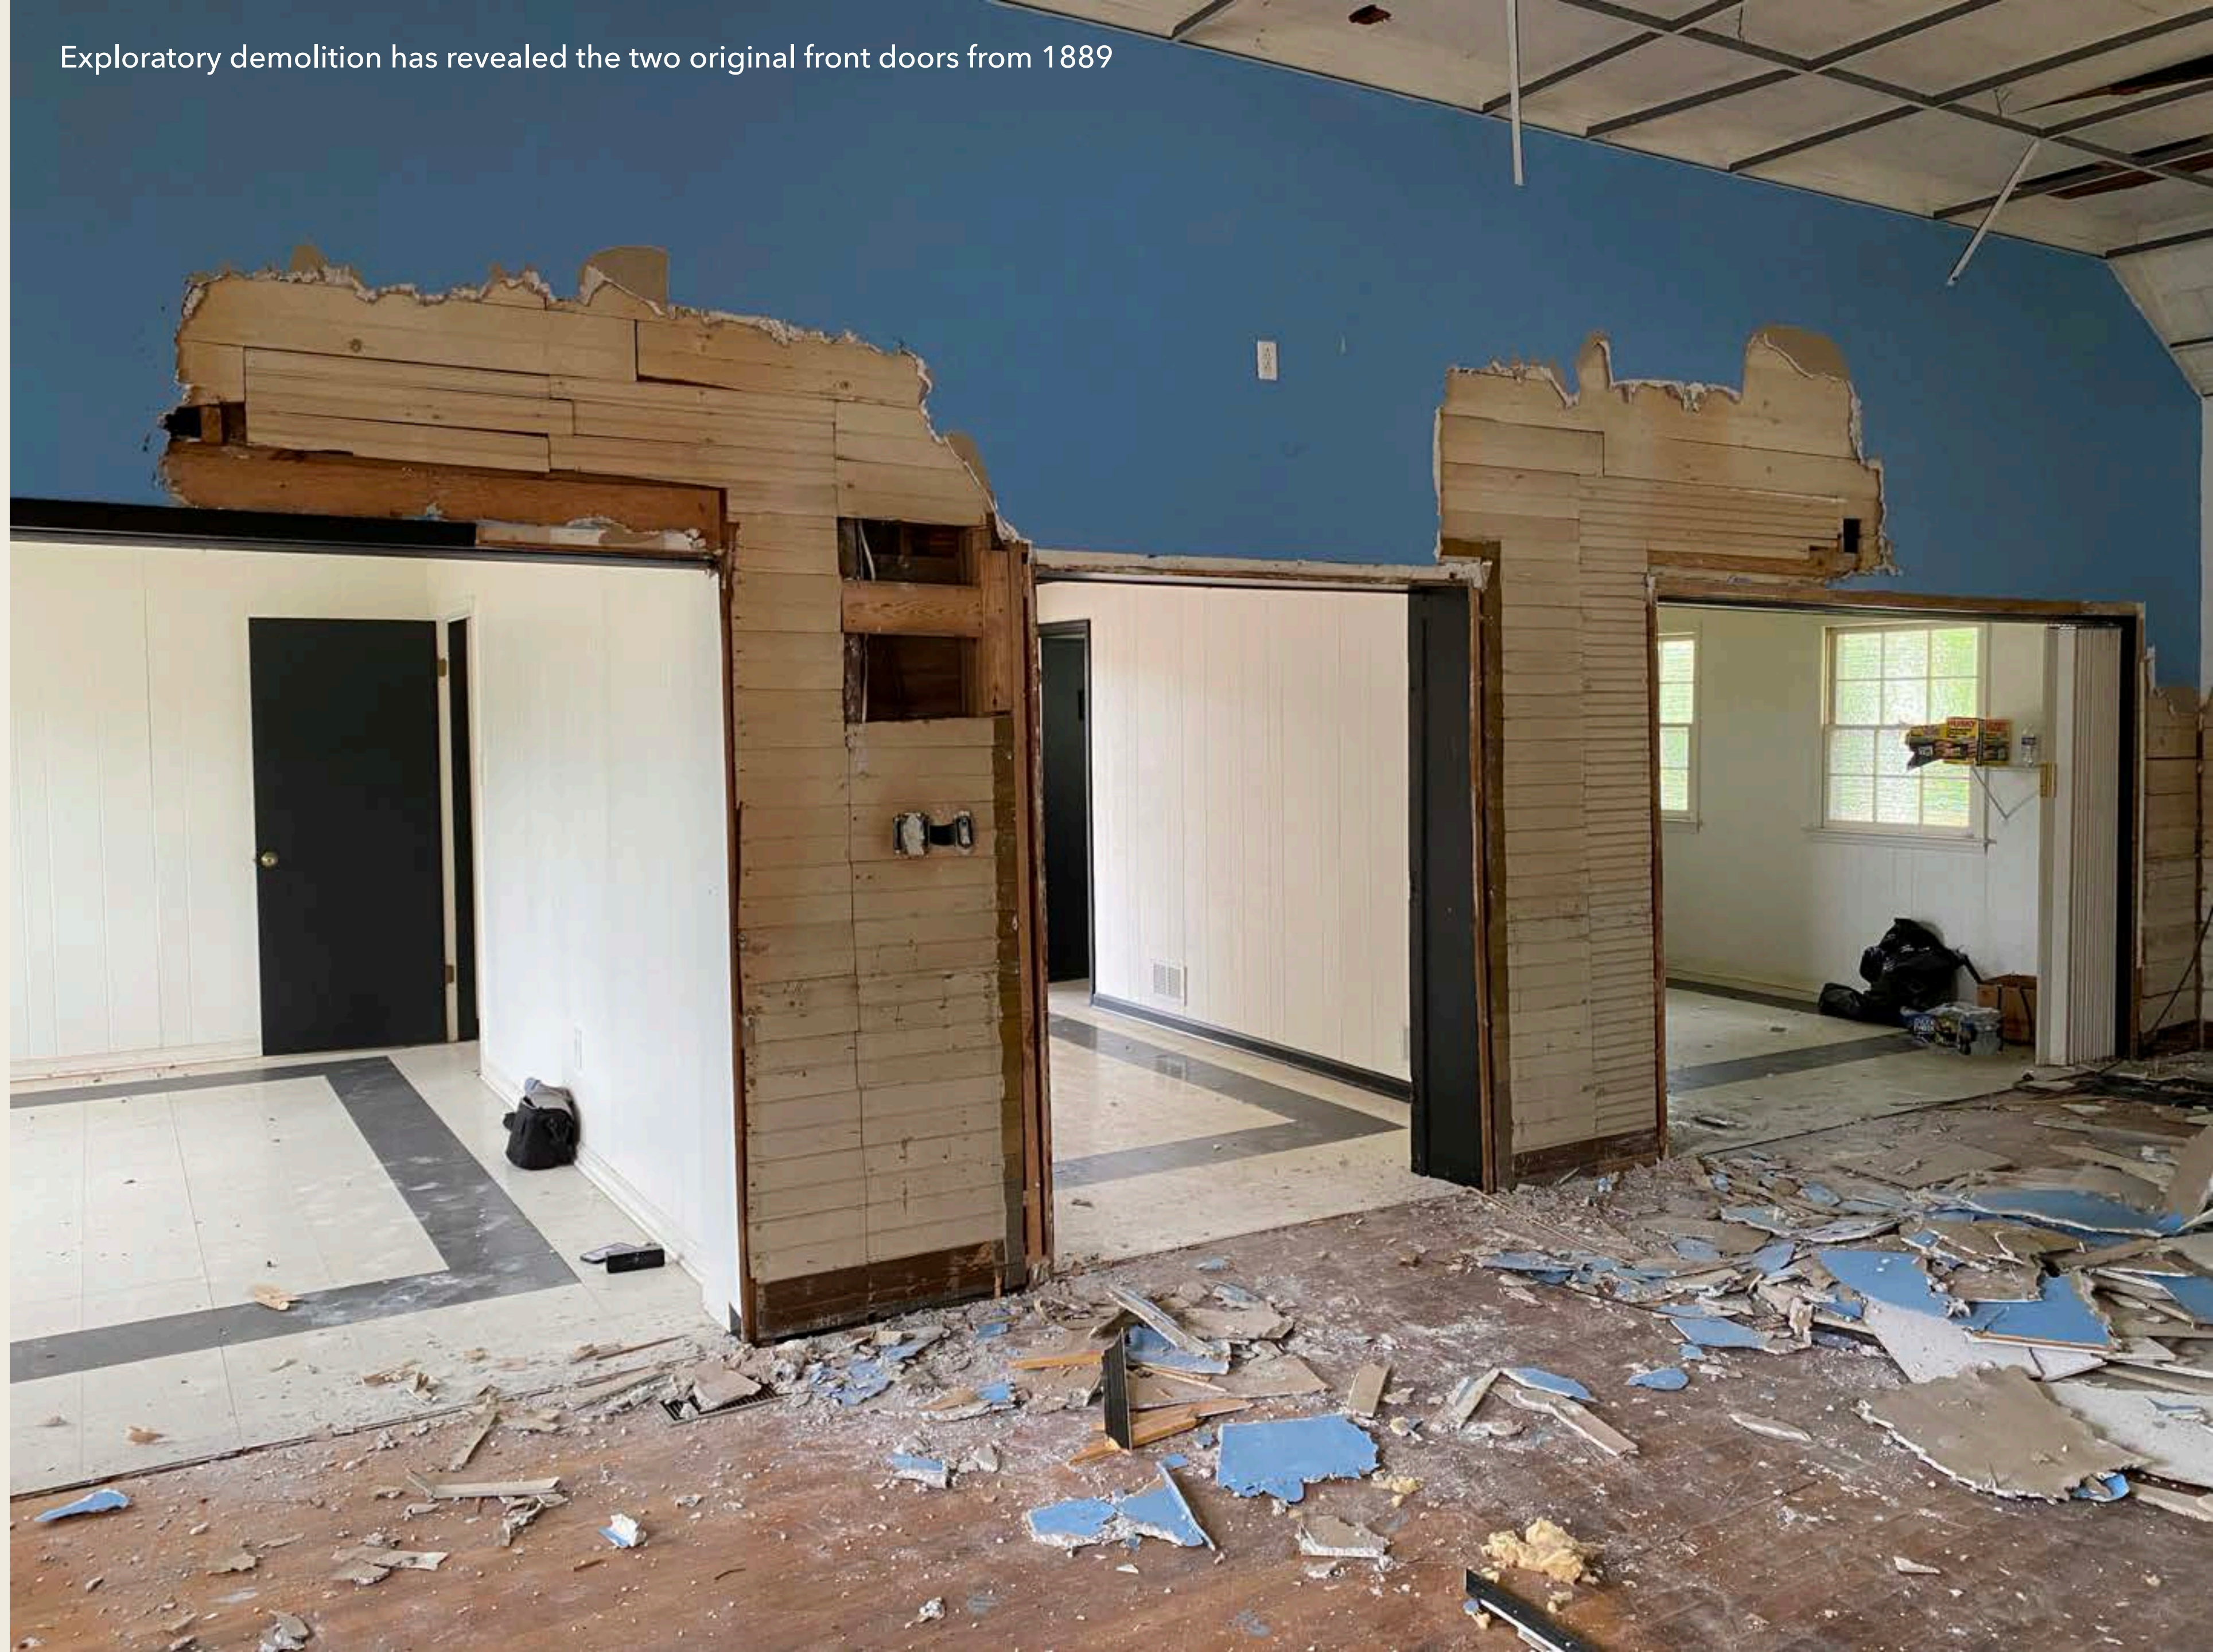
Exploratory demolition has revealed the two original front doors from 1889

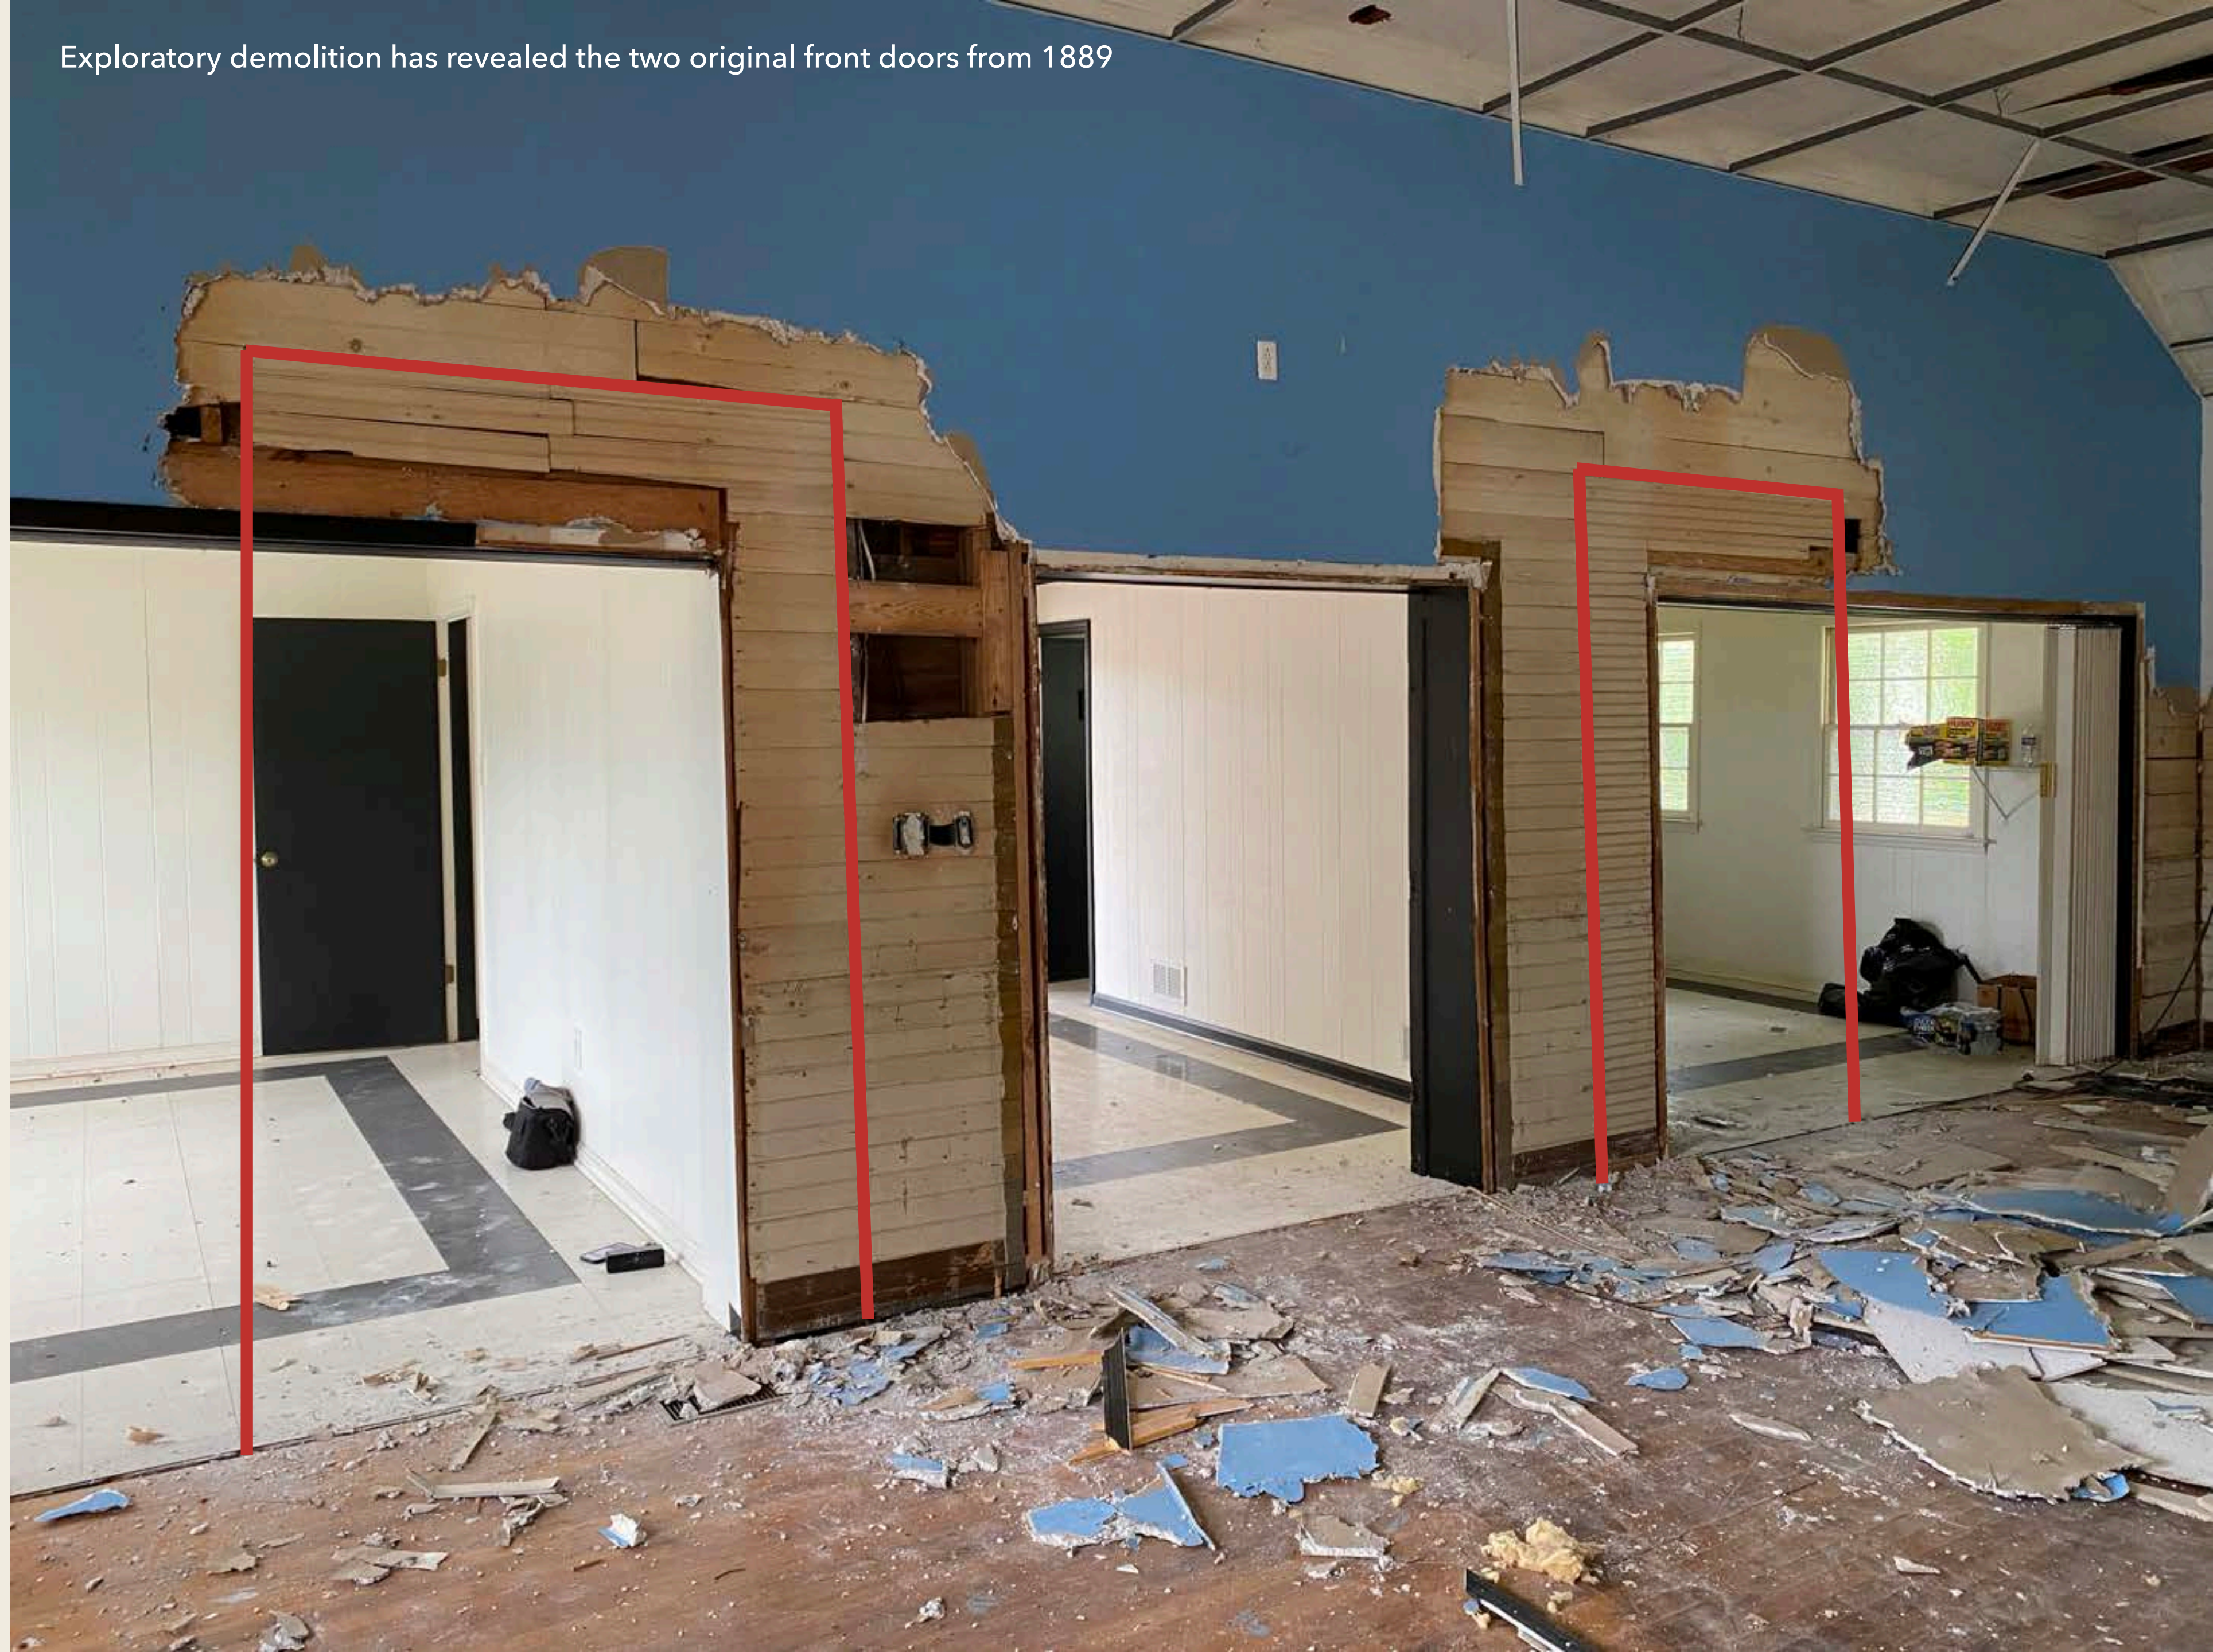
Exploratory demolition has revealed the two original front doors from 1889

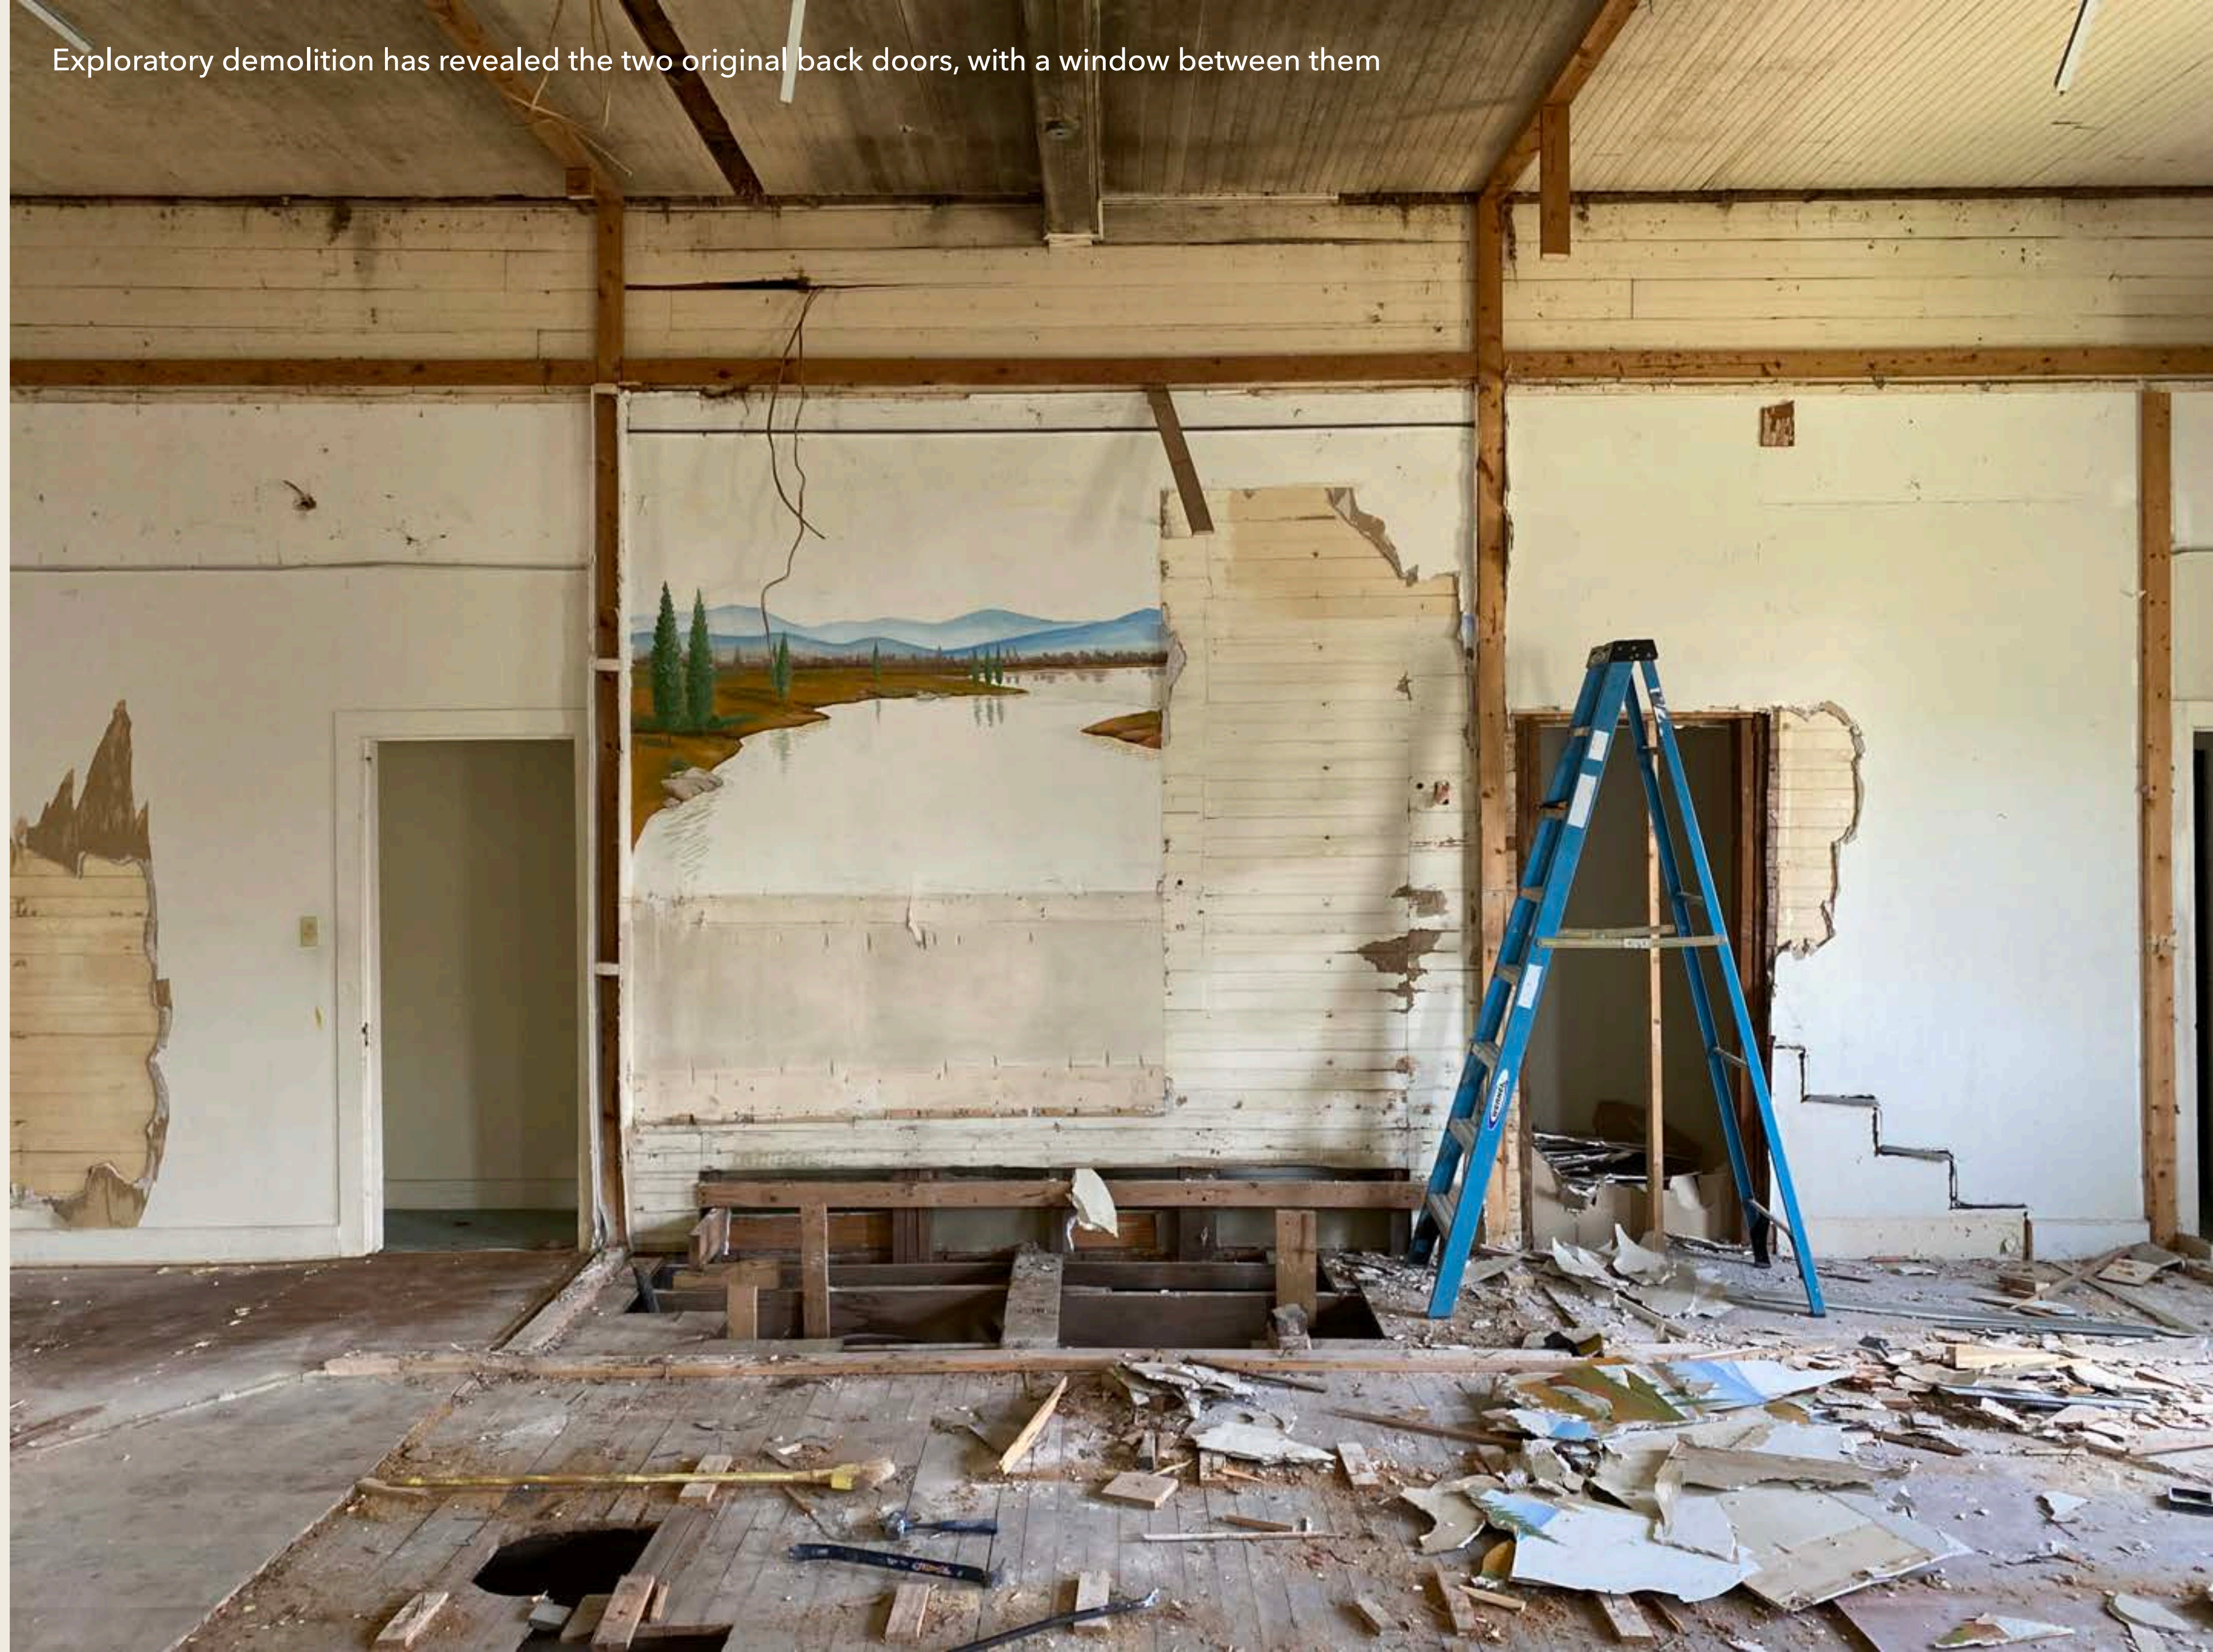
Exploratory demolition has revealed the two original back doors, with a window between them

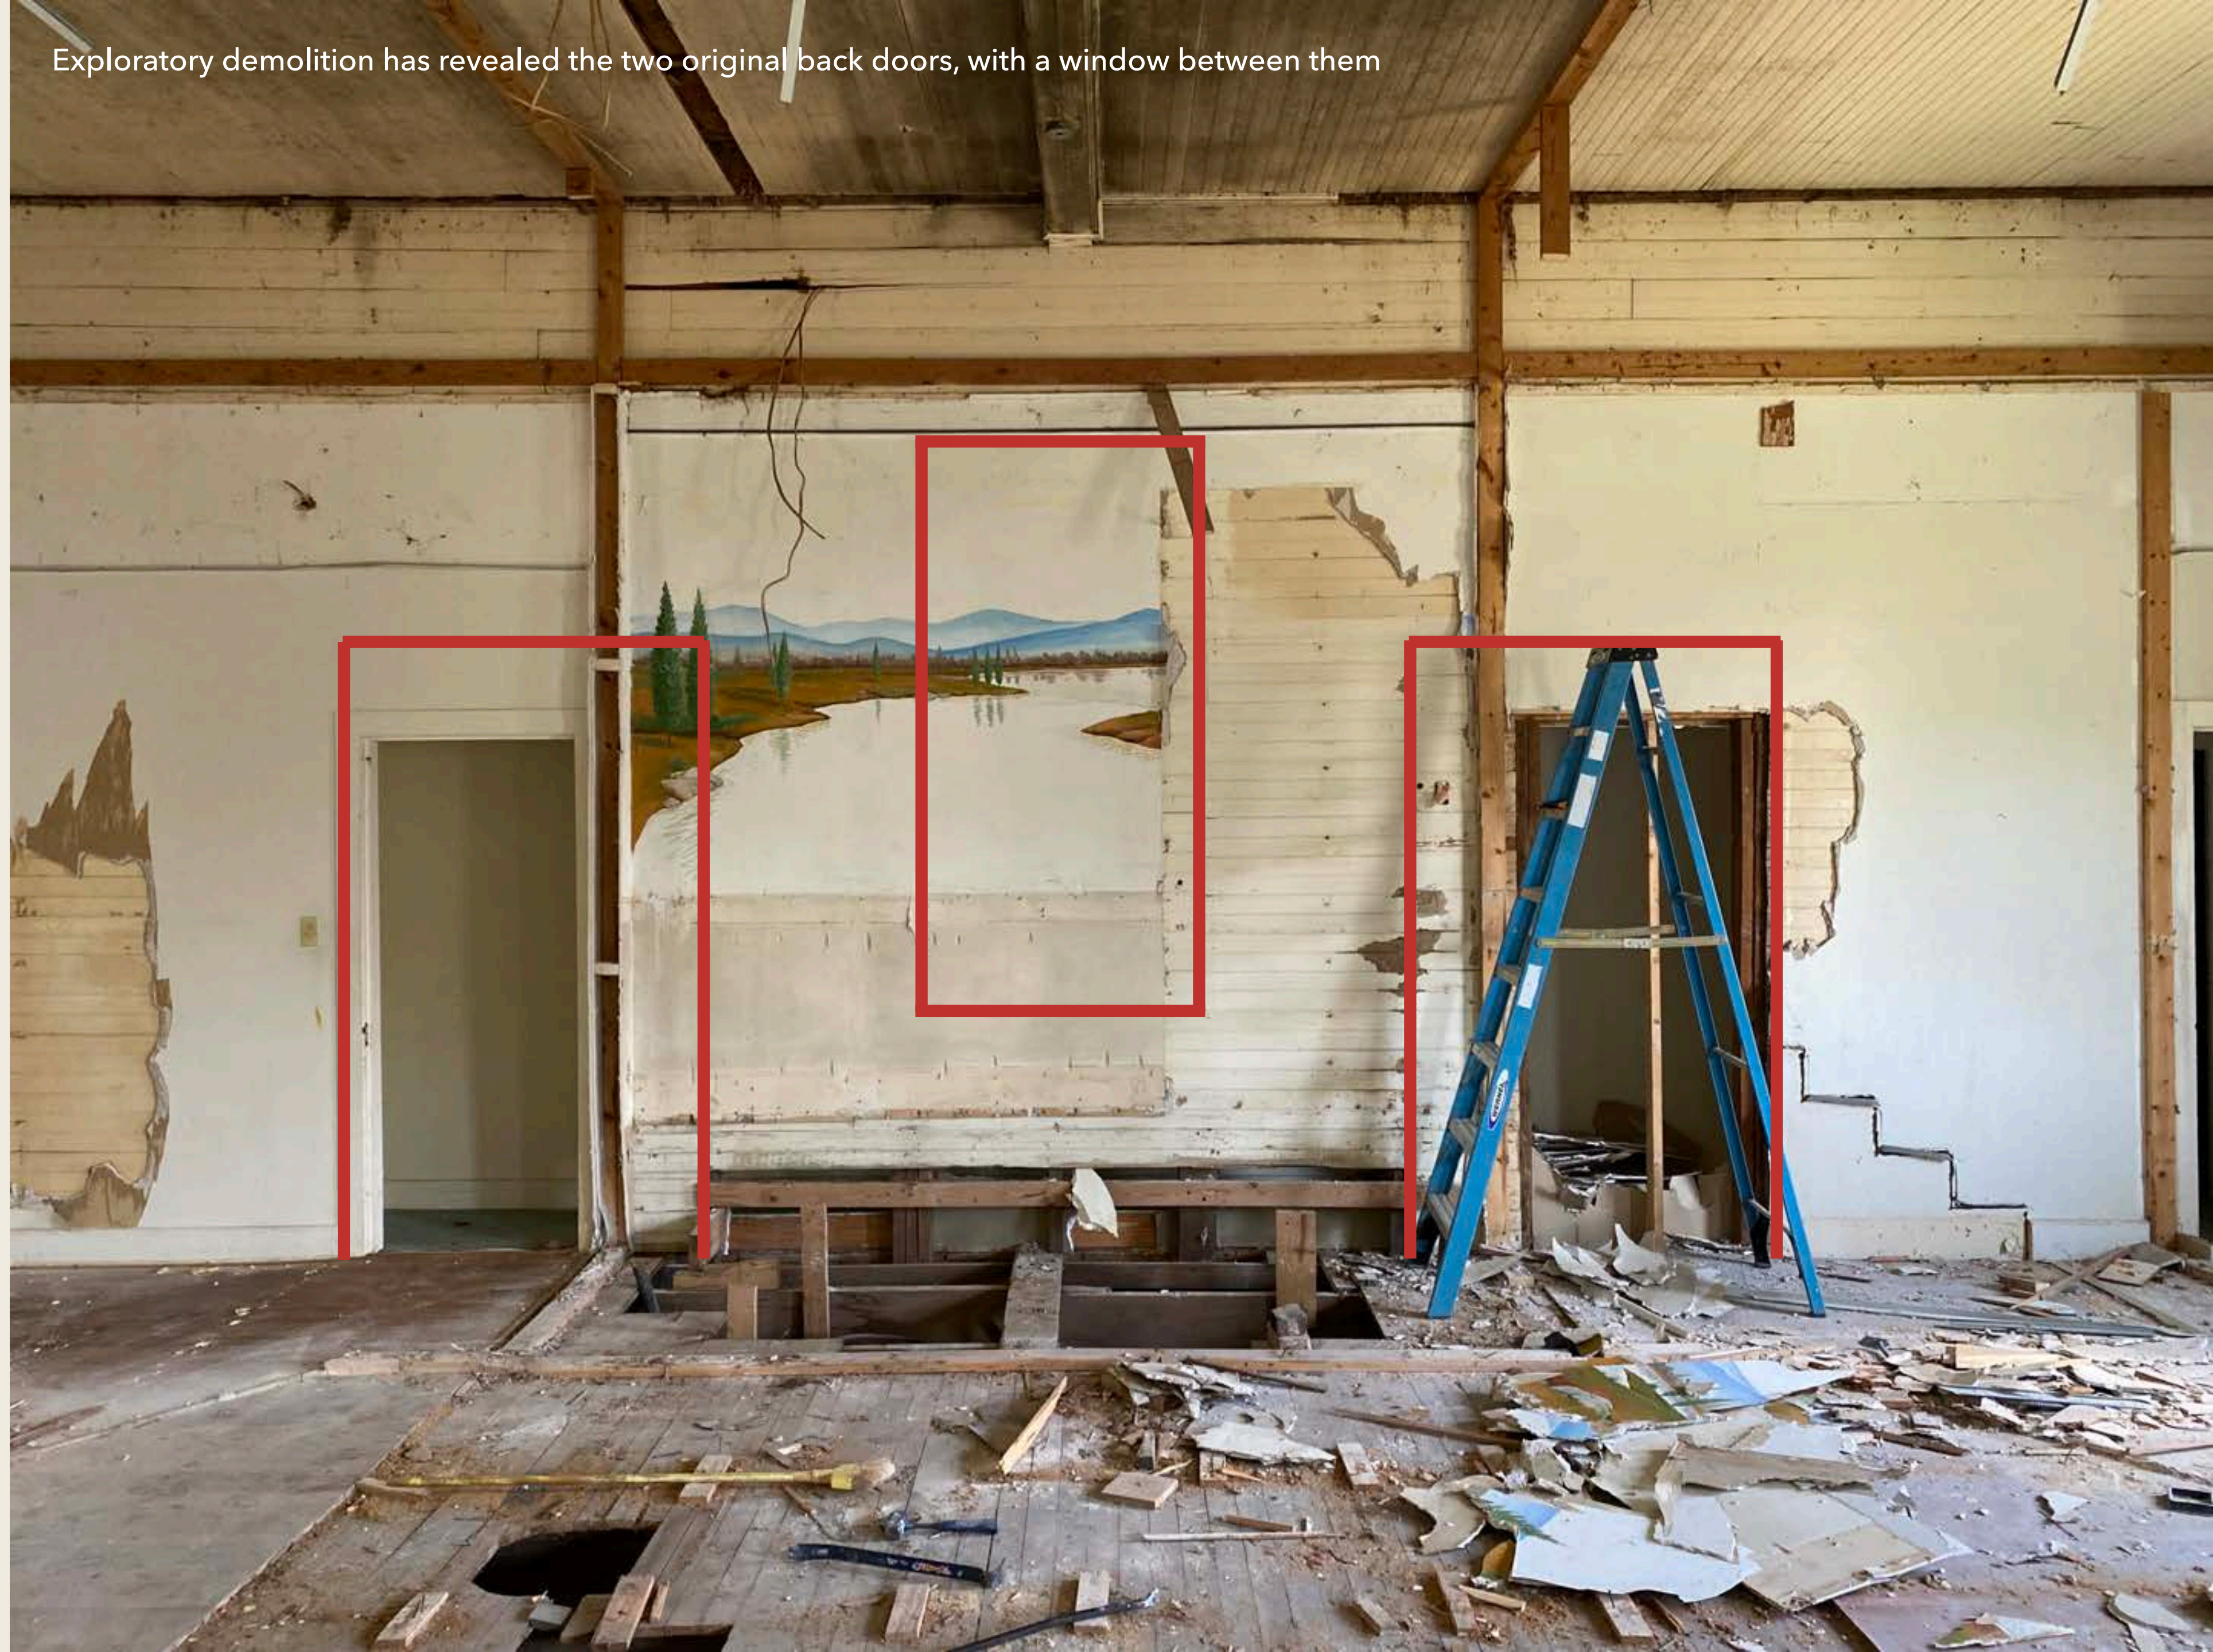
Exploratory demolition has revealed the two original back doors, with a window between them

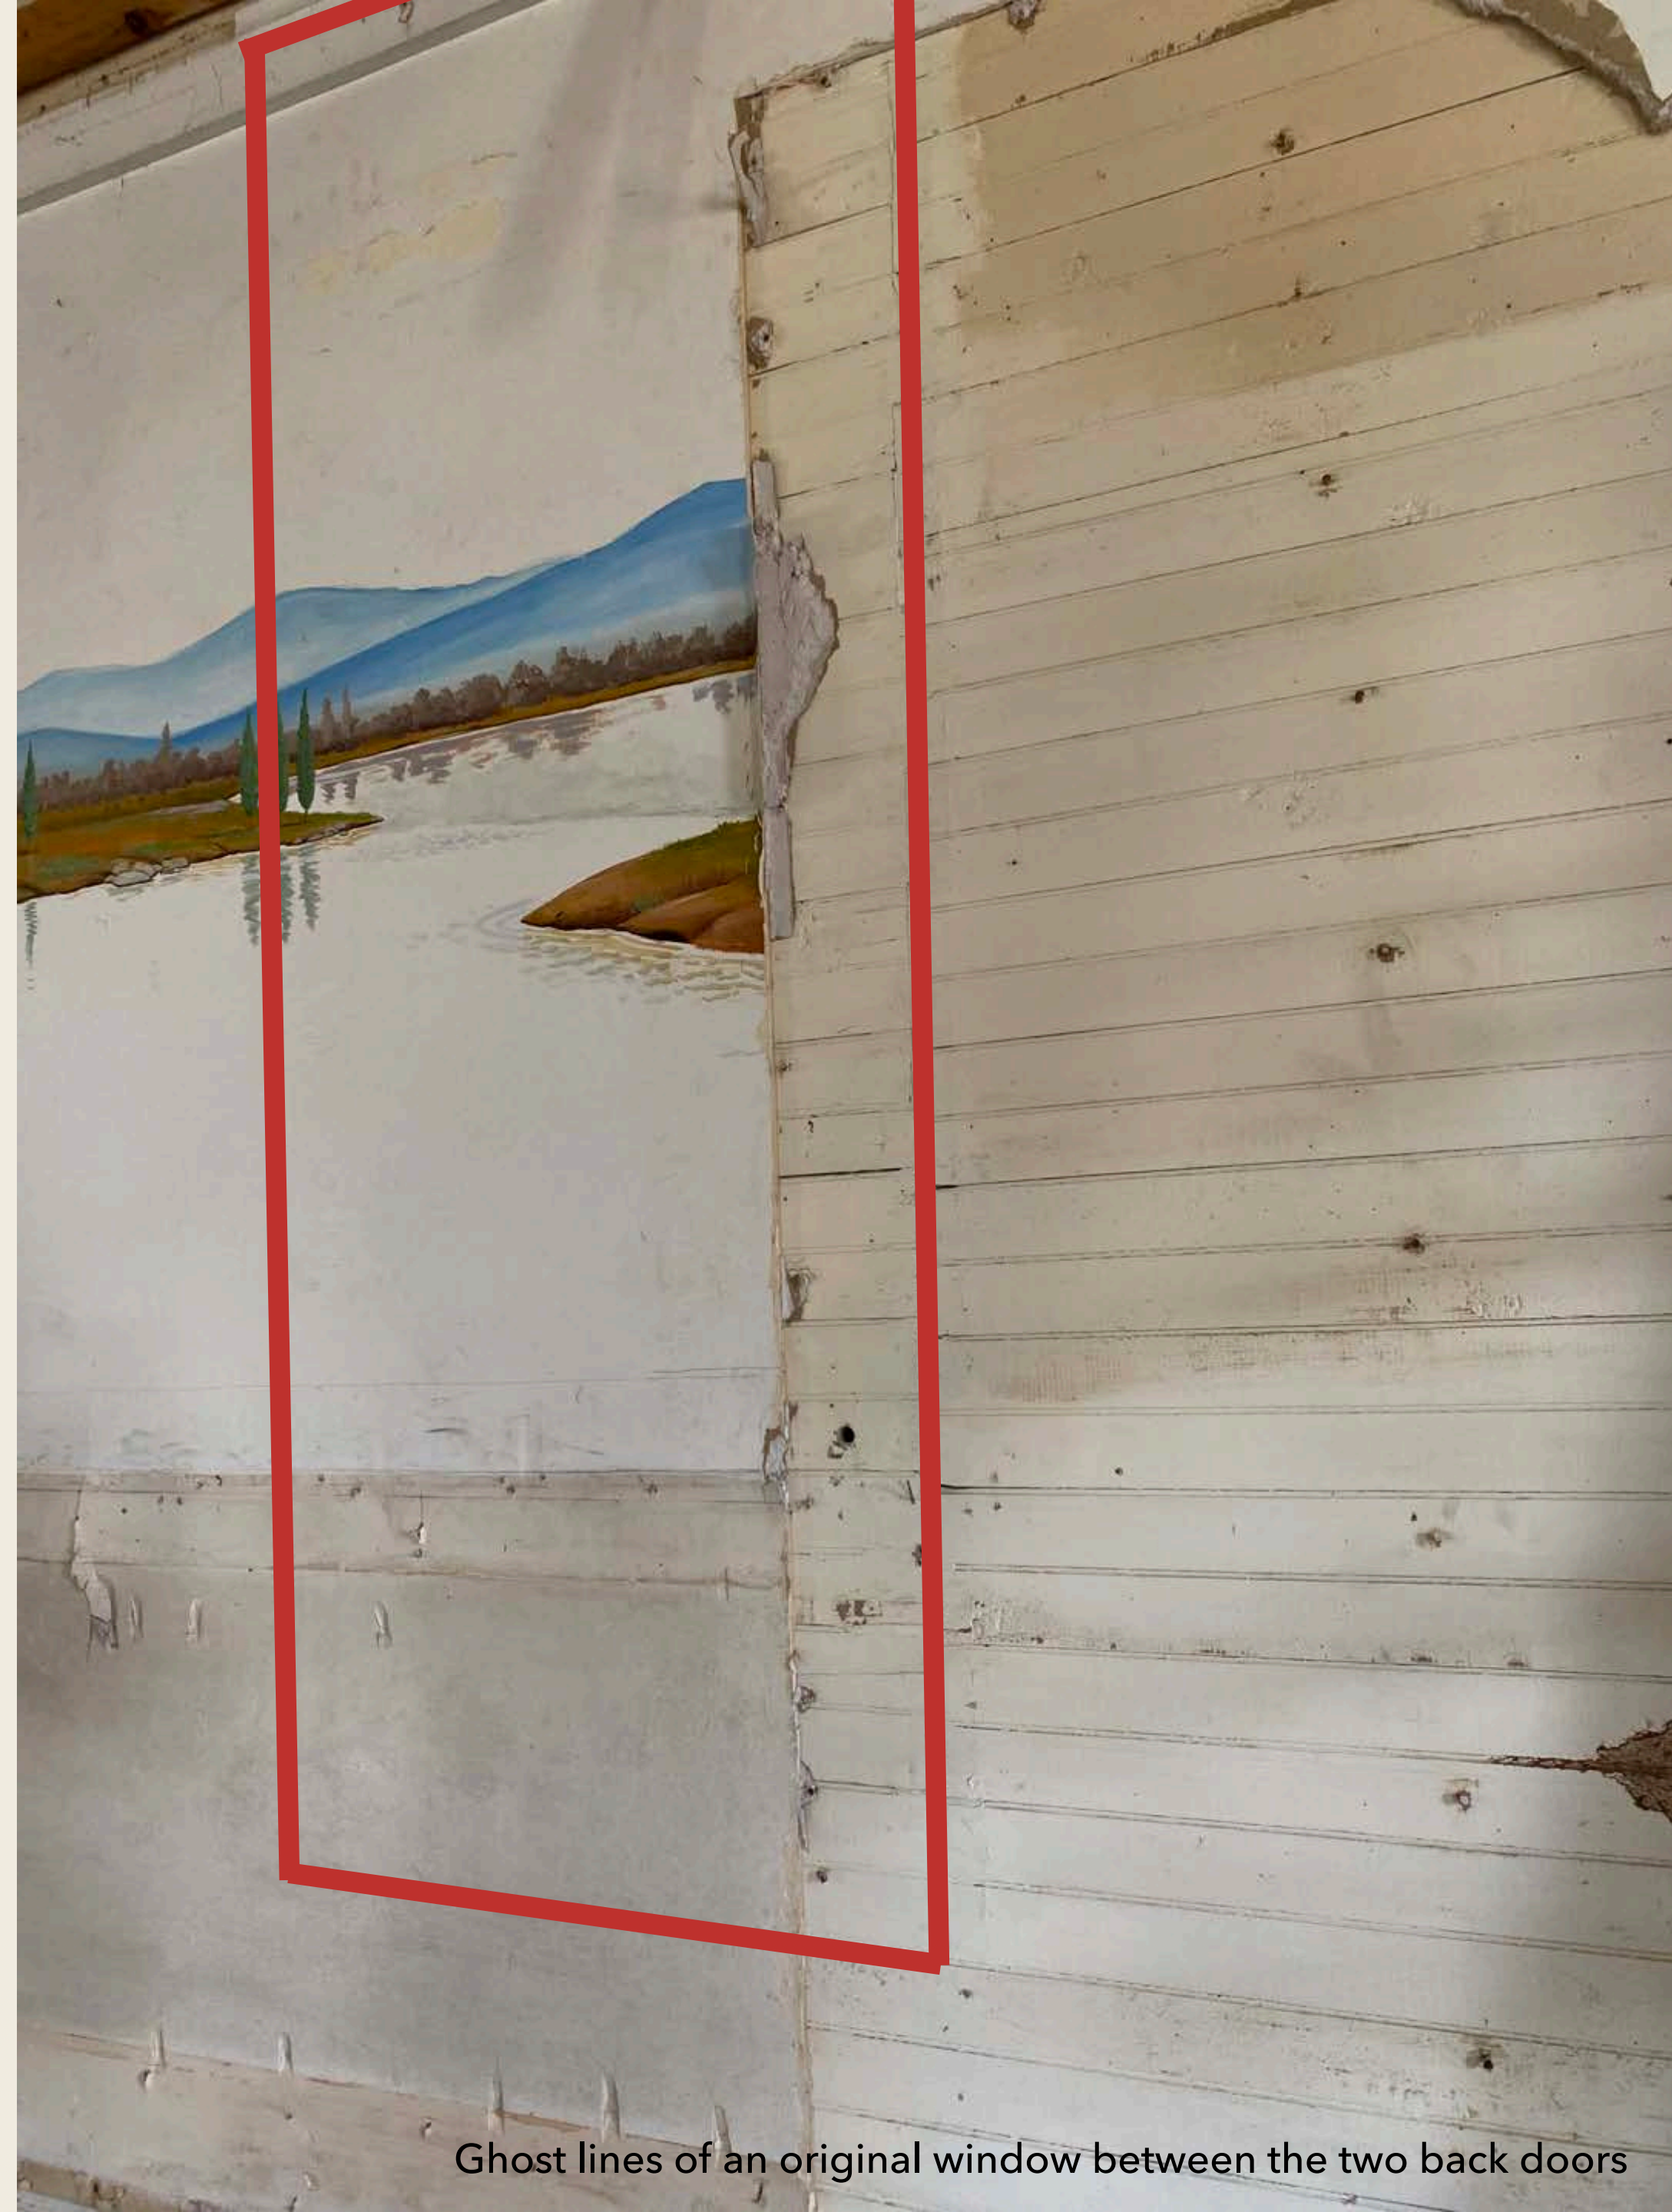
Ghost lines of an original window between the two back doors
