# Historic Woolsey Church

Resurrecting a local landmark

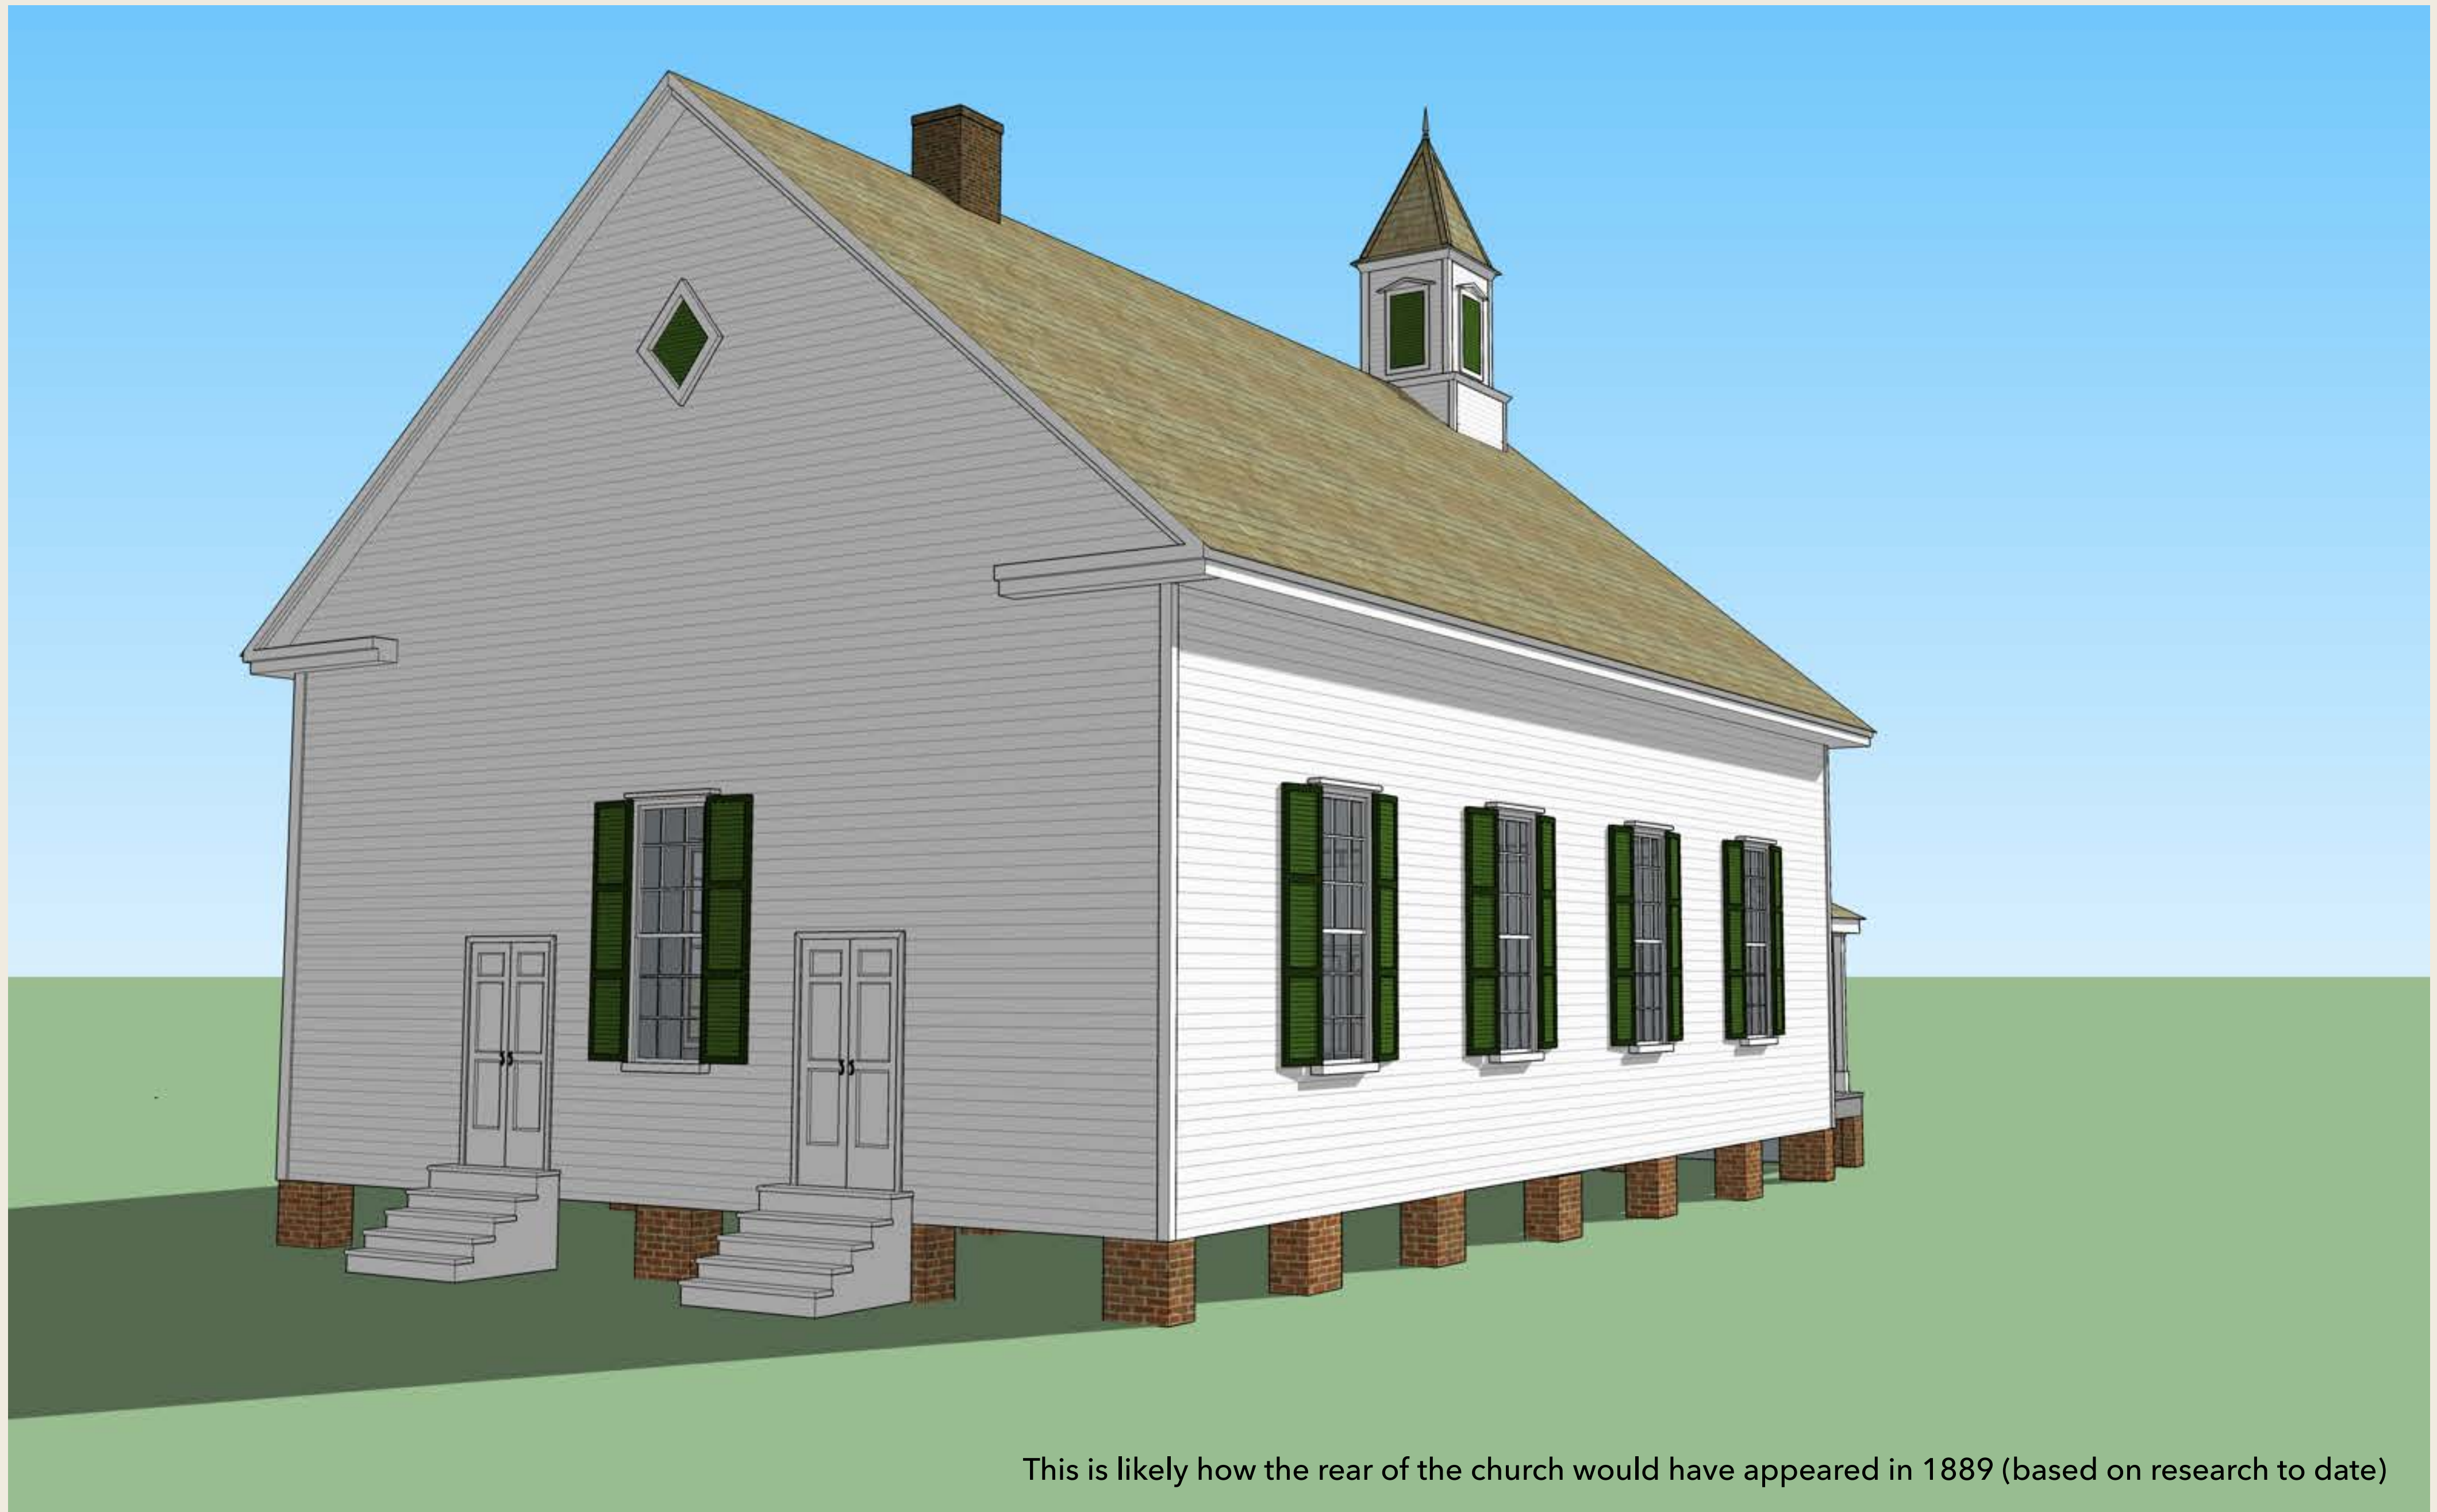
Ghost lines of an original window between the two back doors

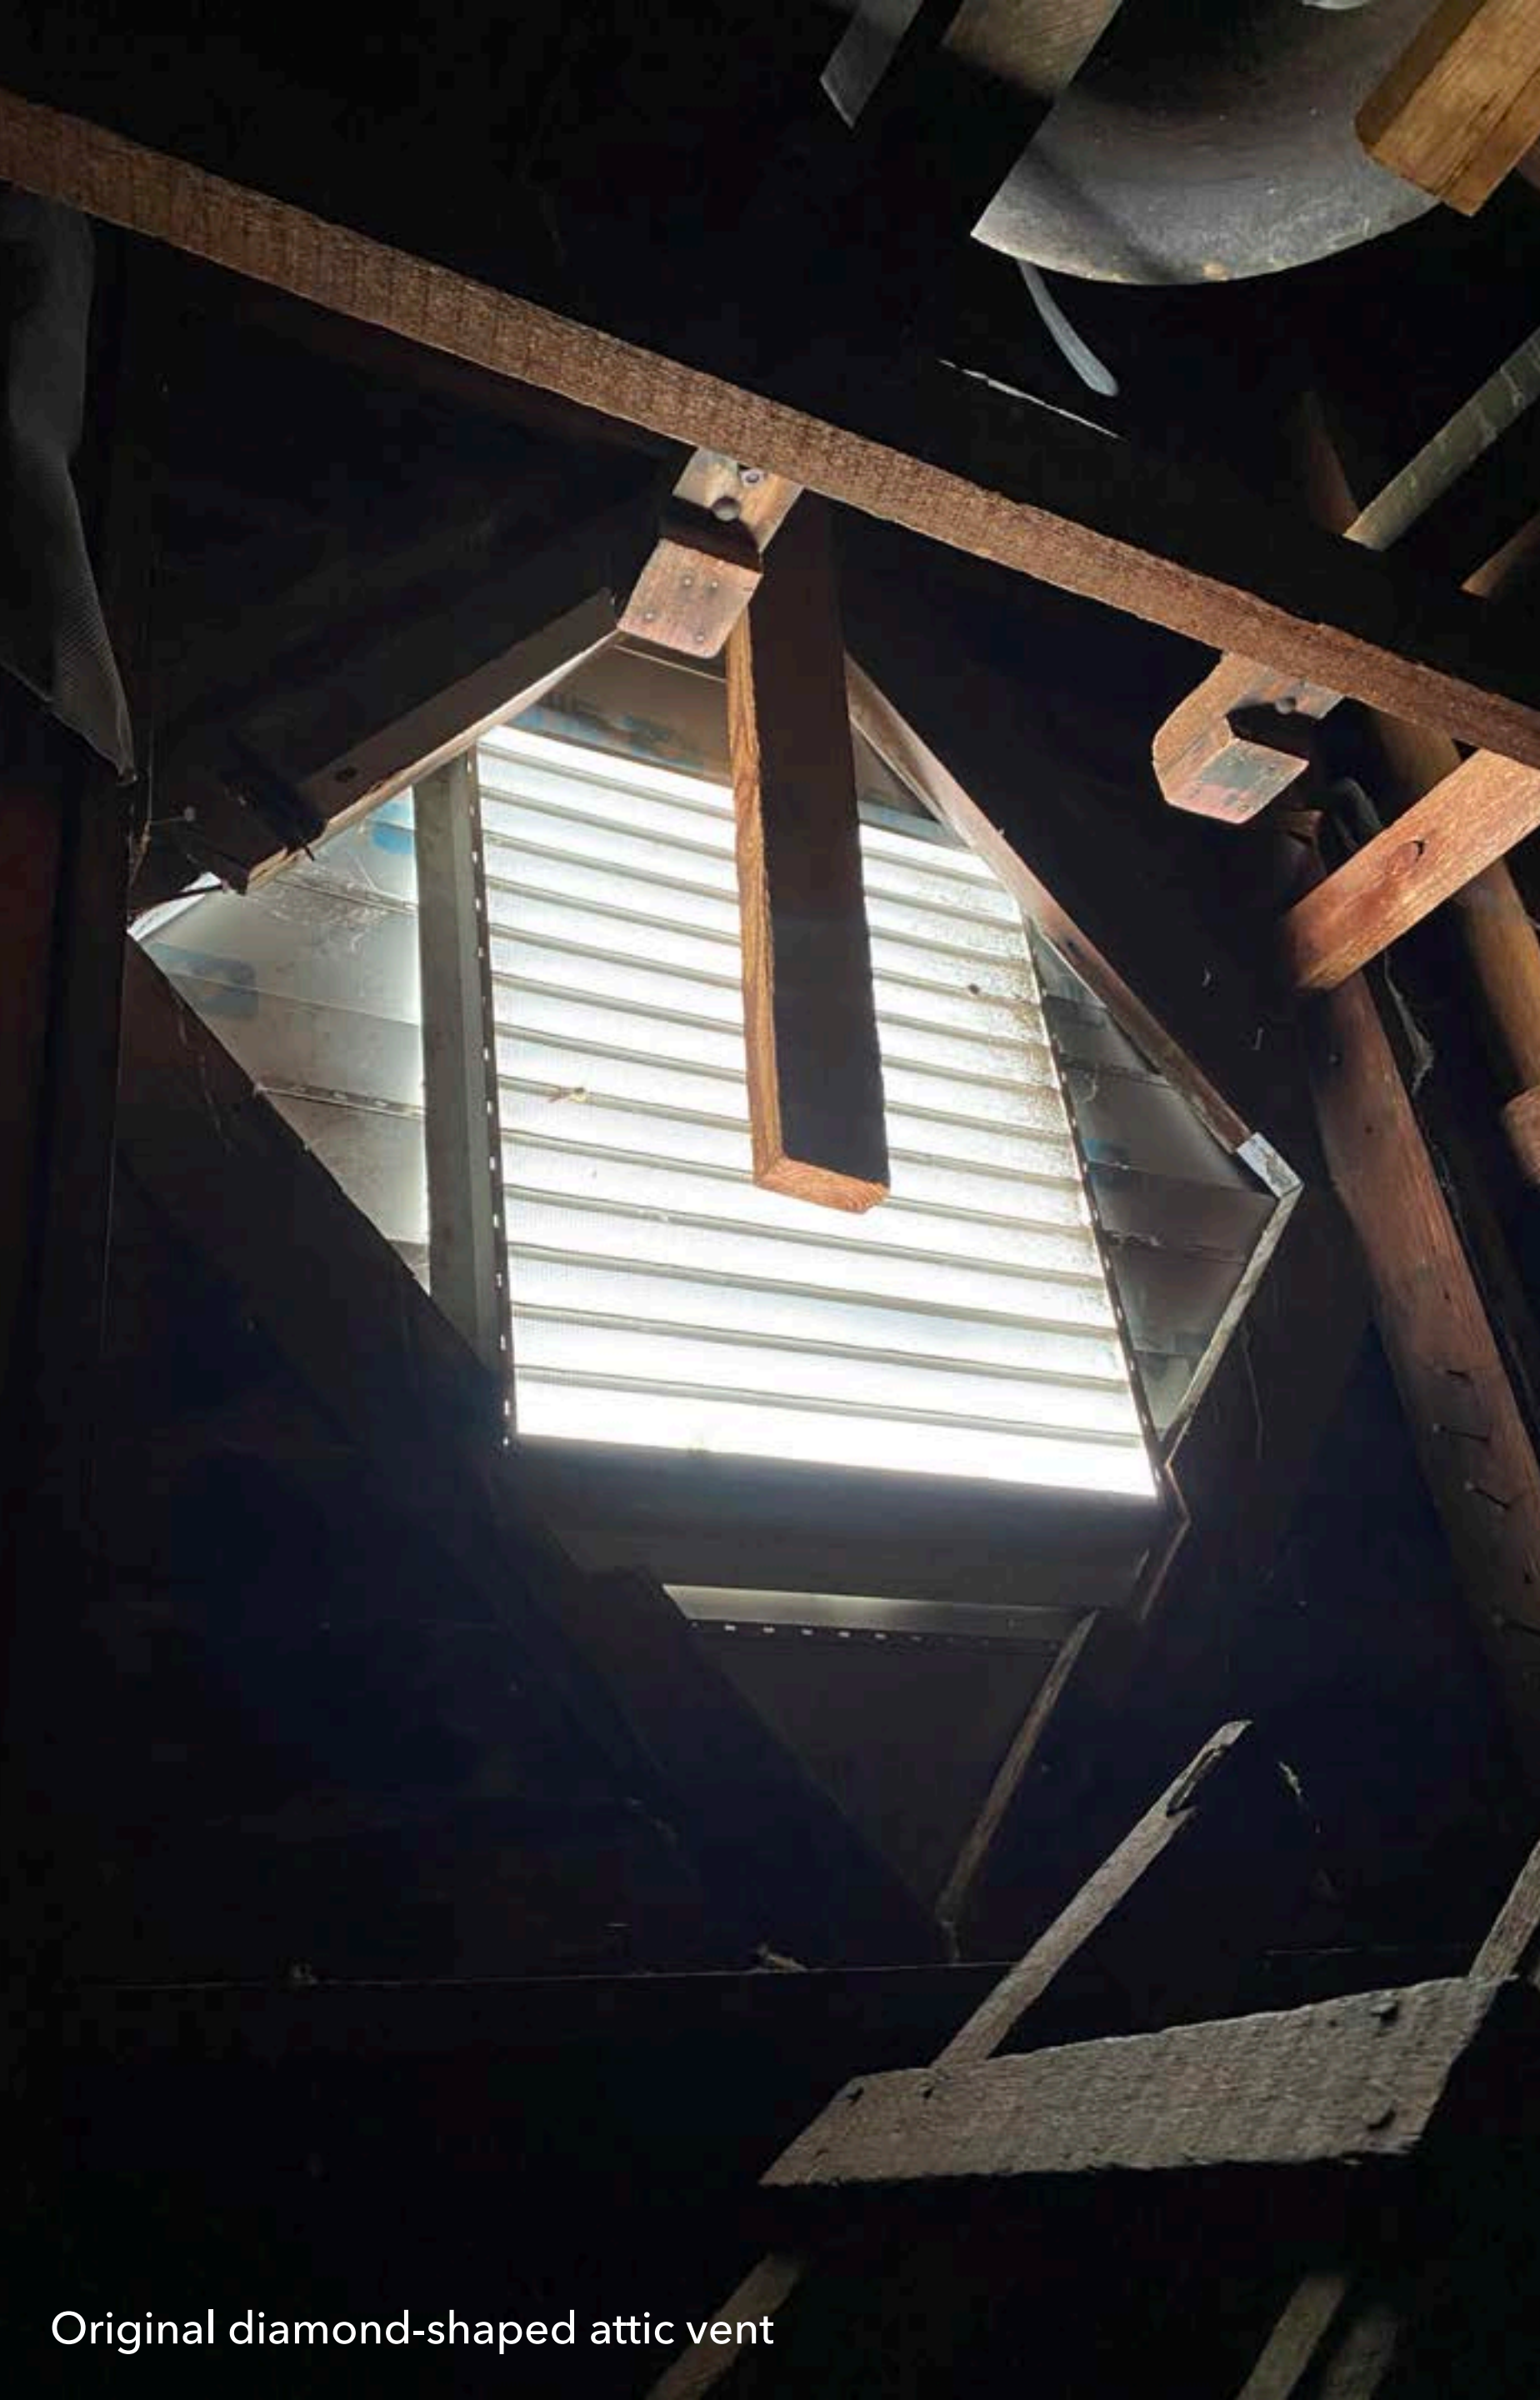
This is likely how the rear of the church would have appeared in 1889 (based on research to date)

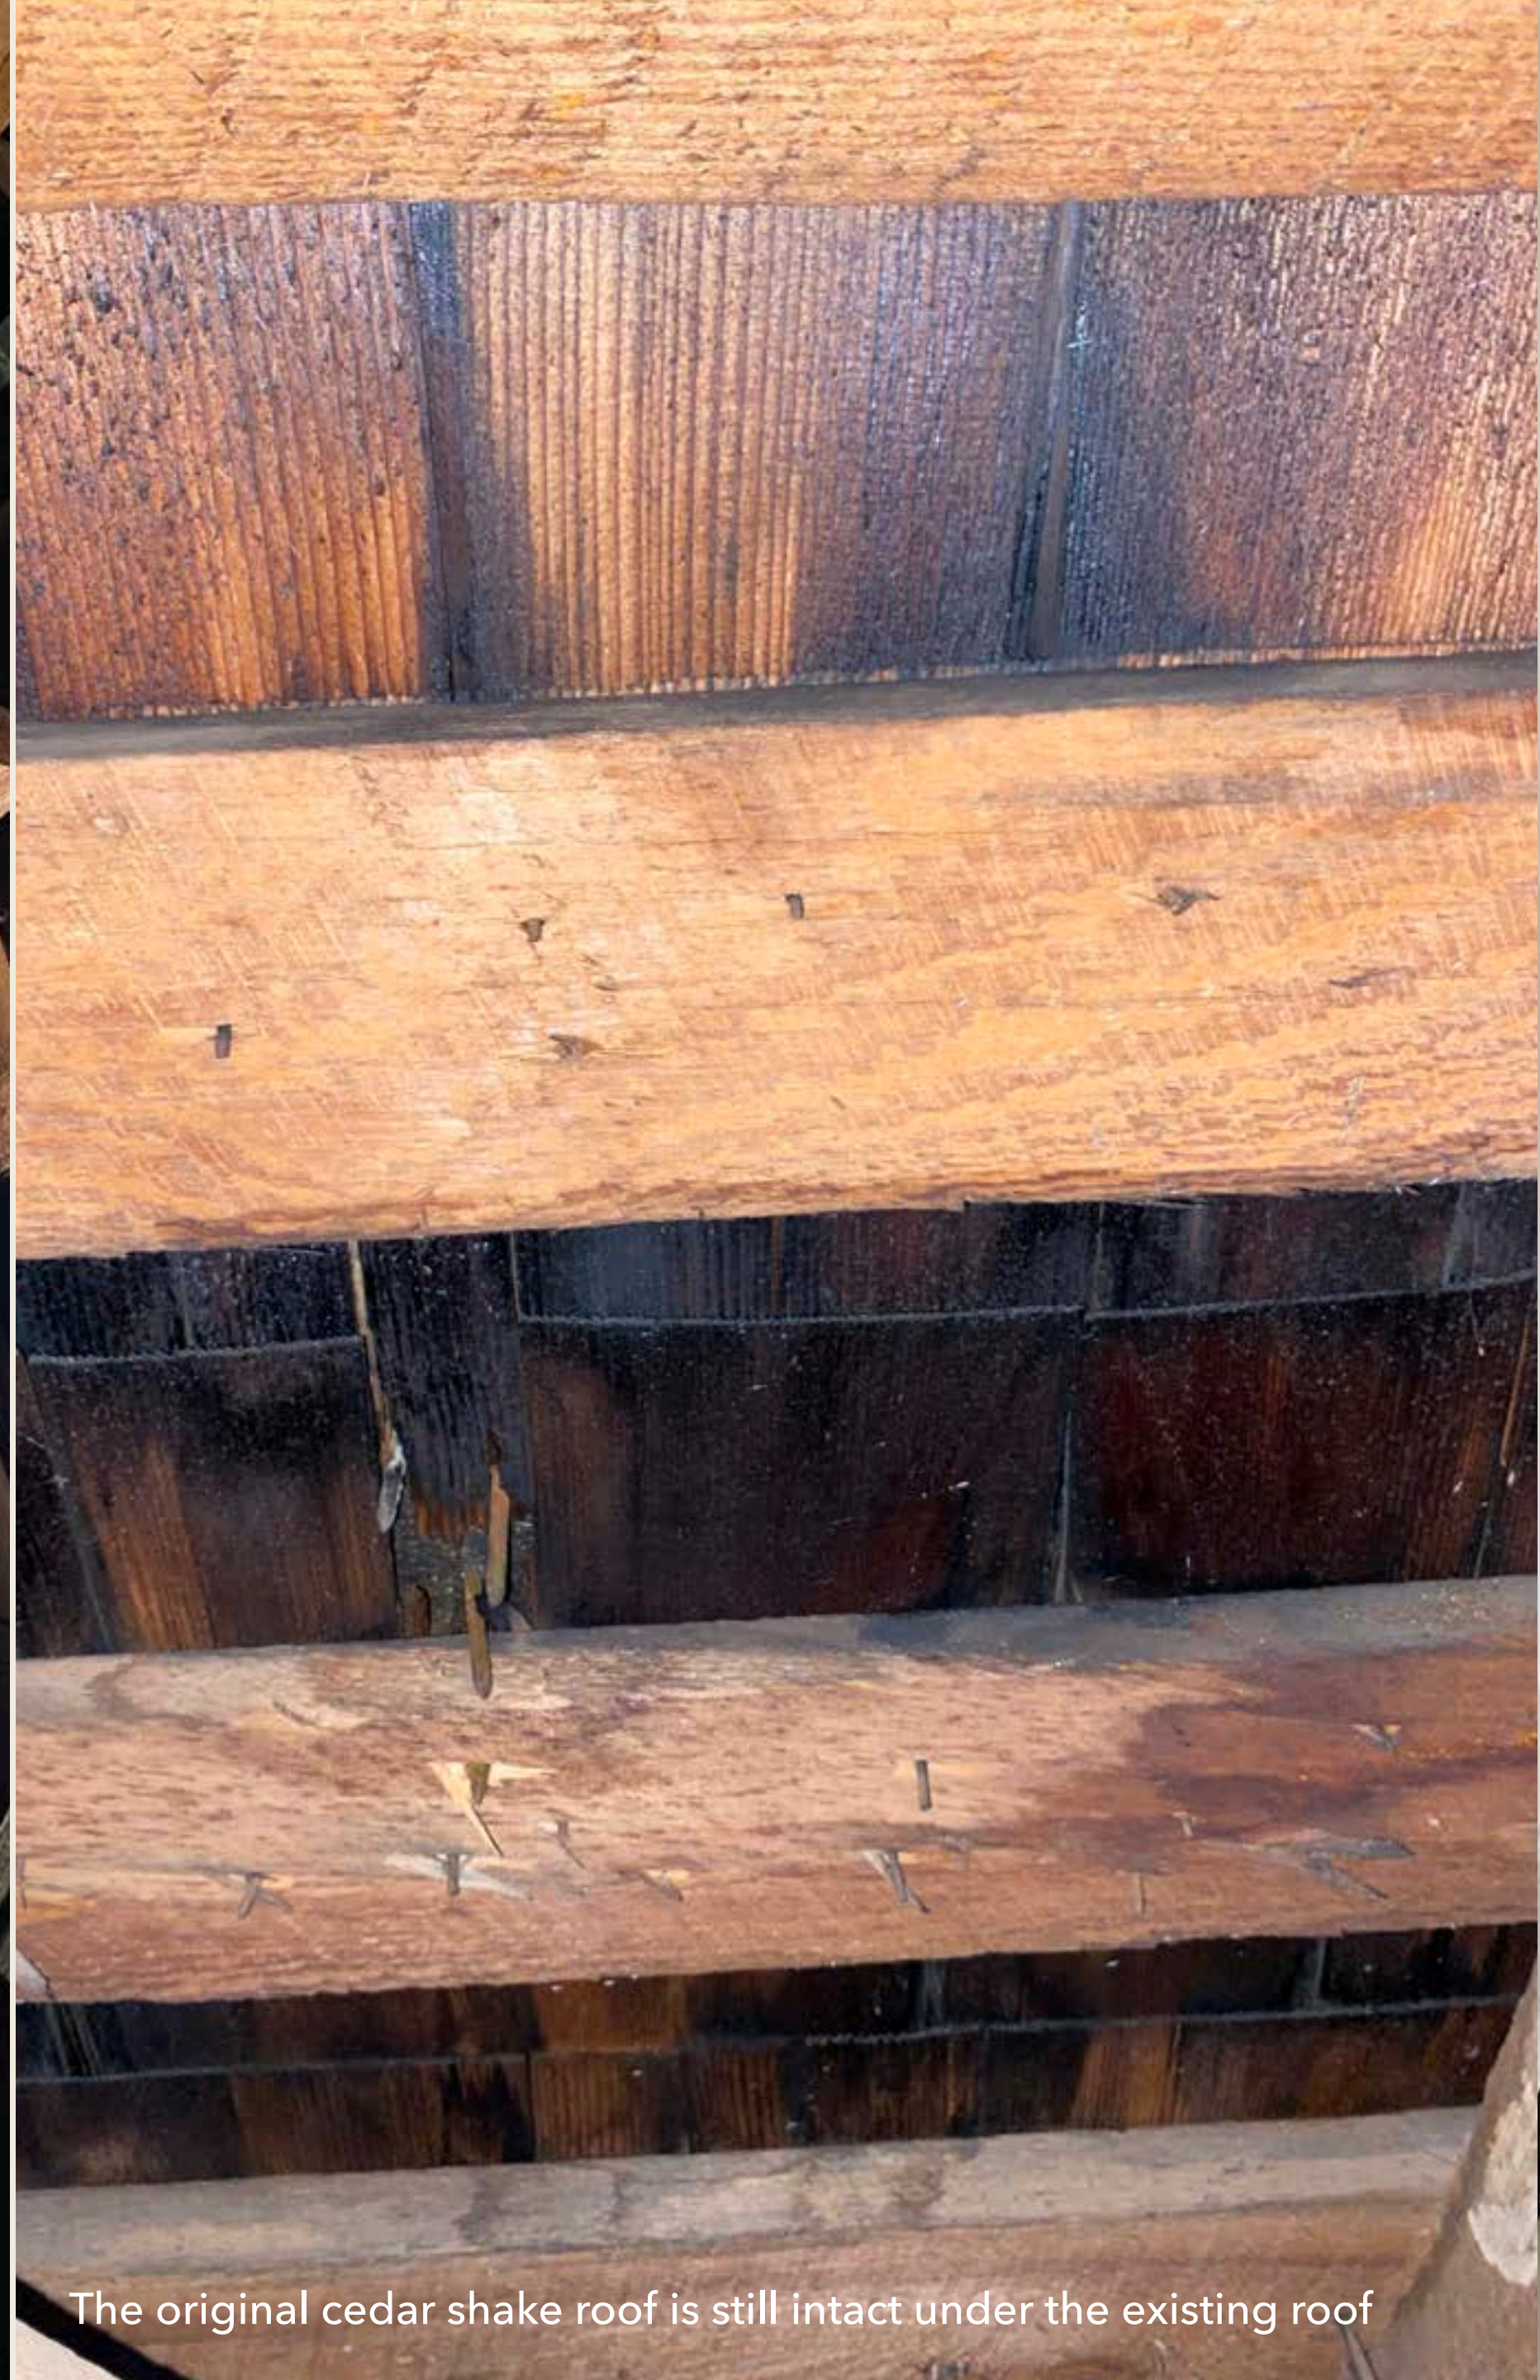
Original diamond-shaped attic vent

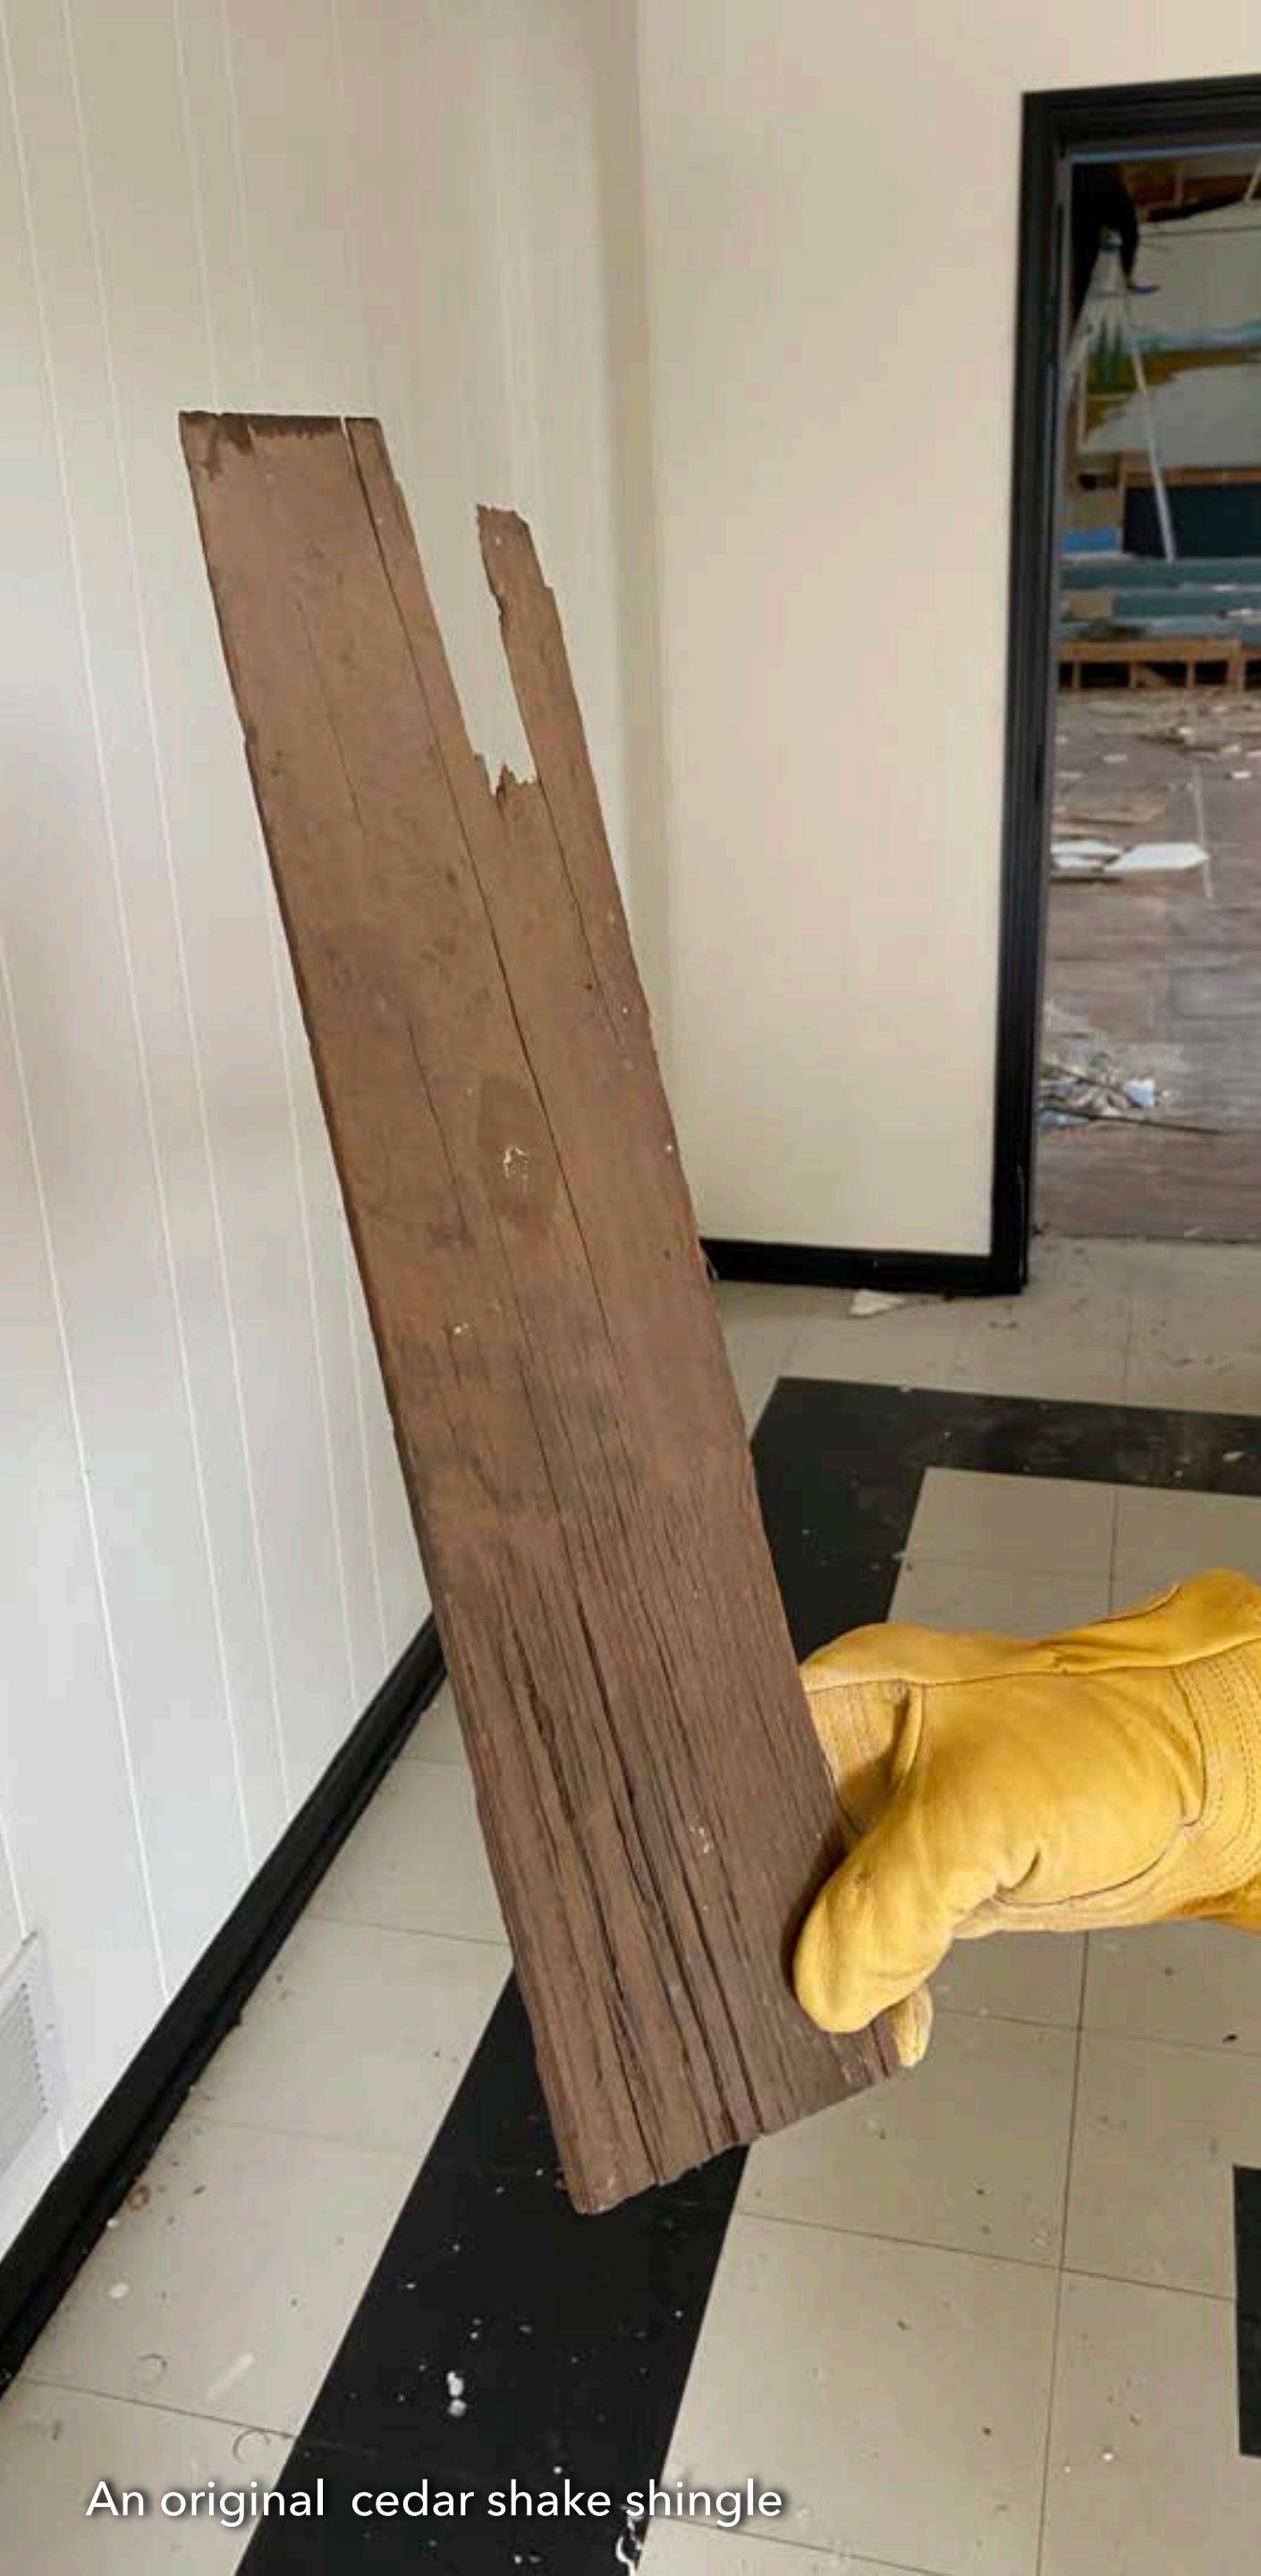
The original cedar shake roof is still intact under the existing roof

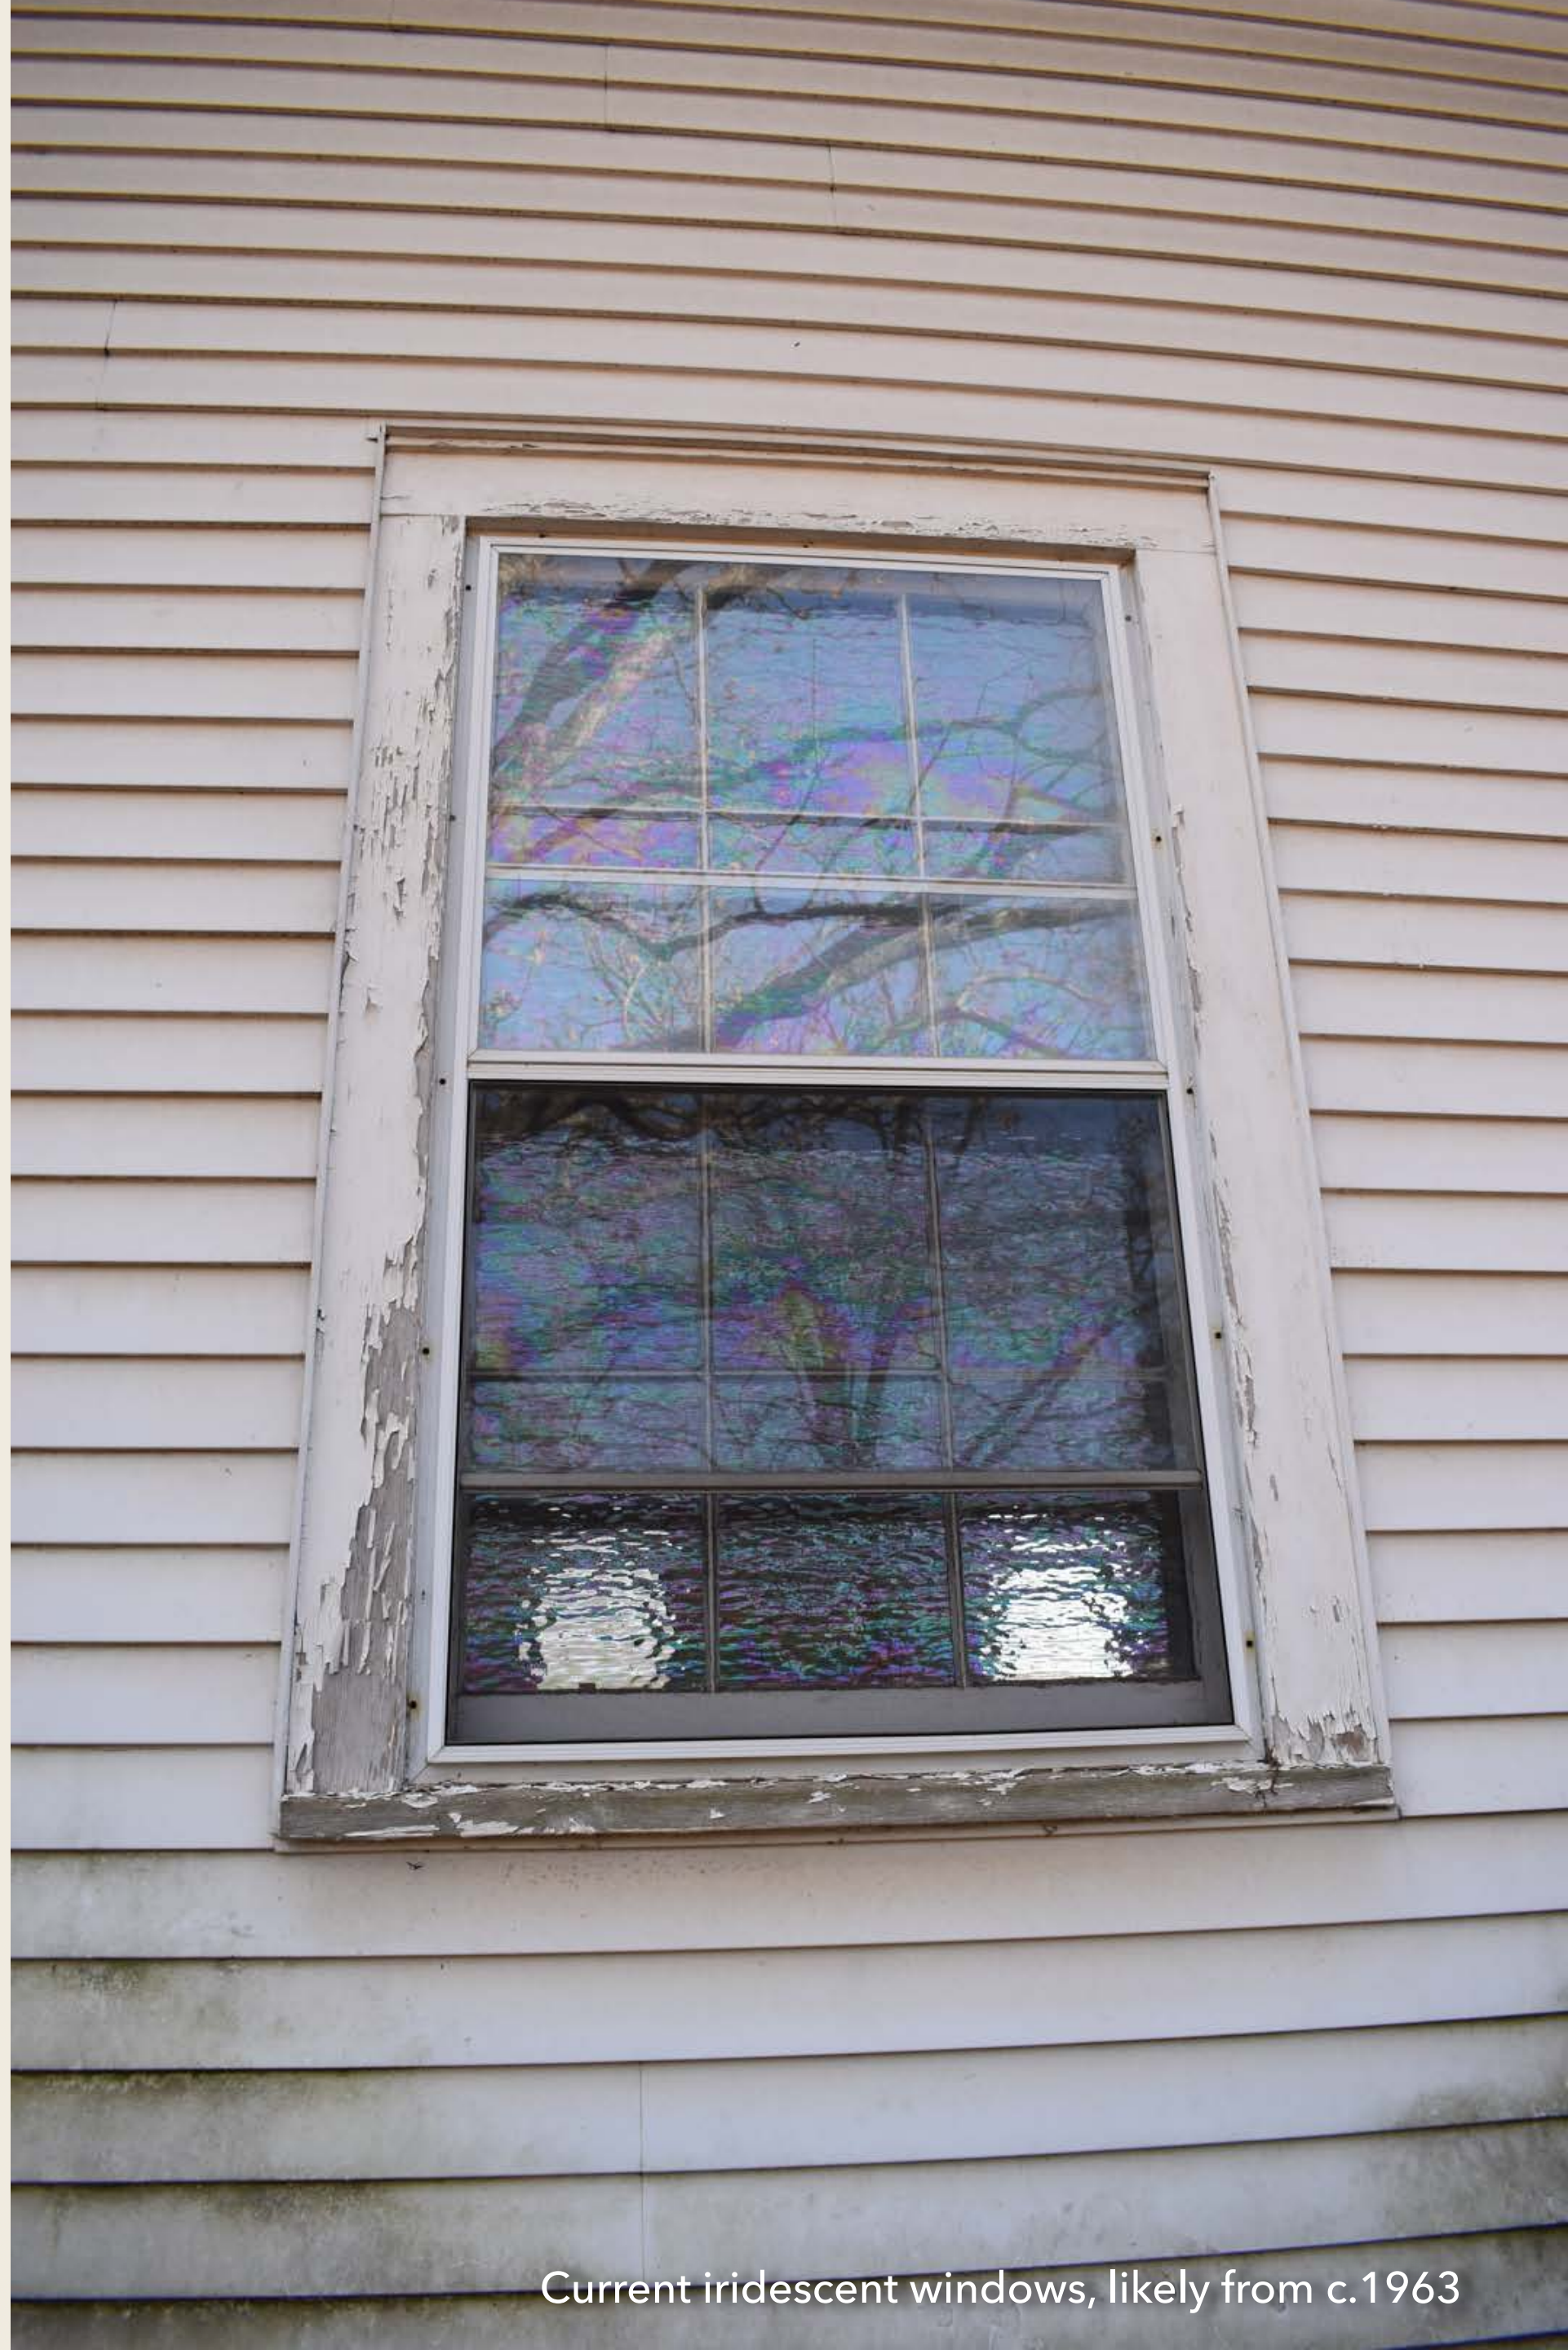
An original cedar shake shingle

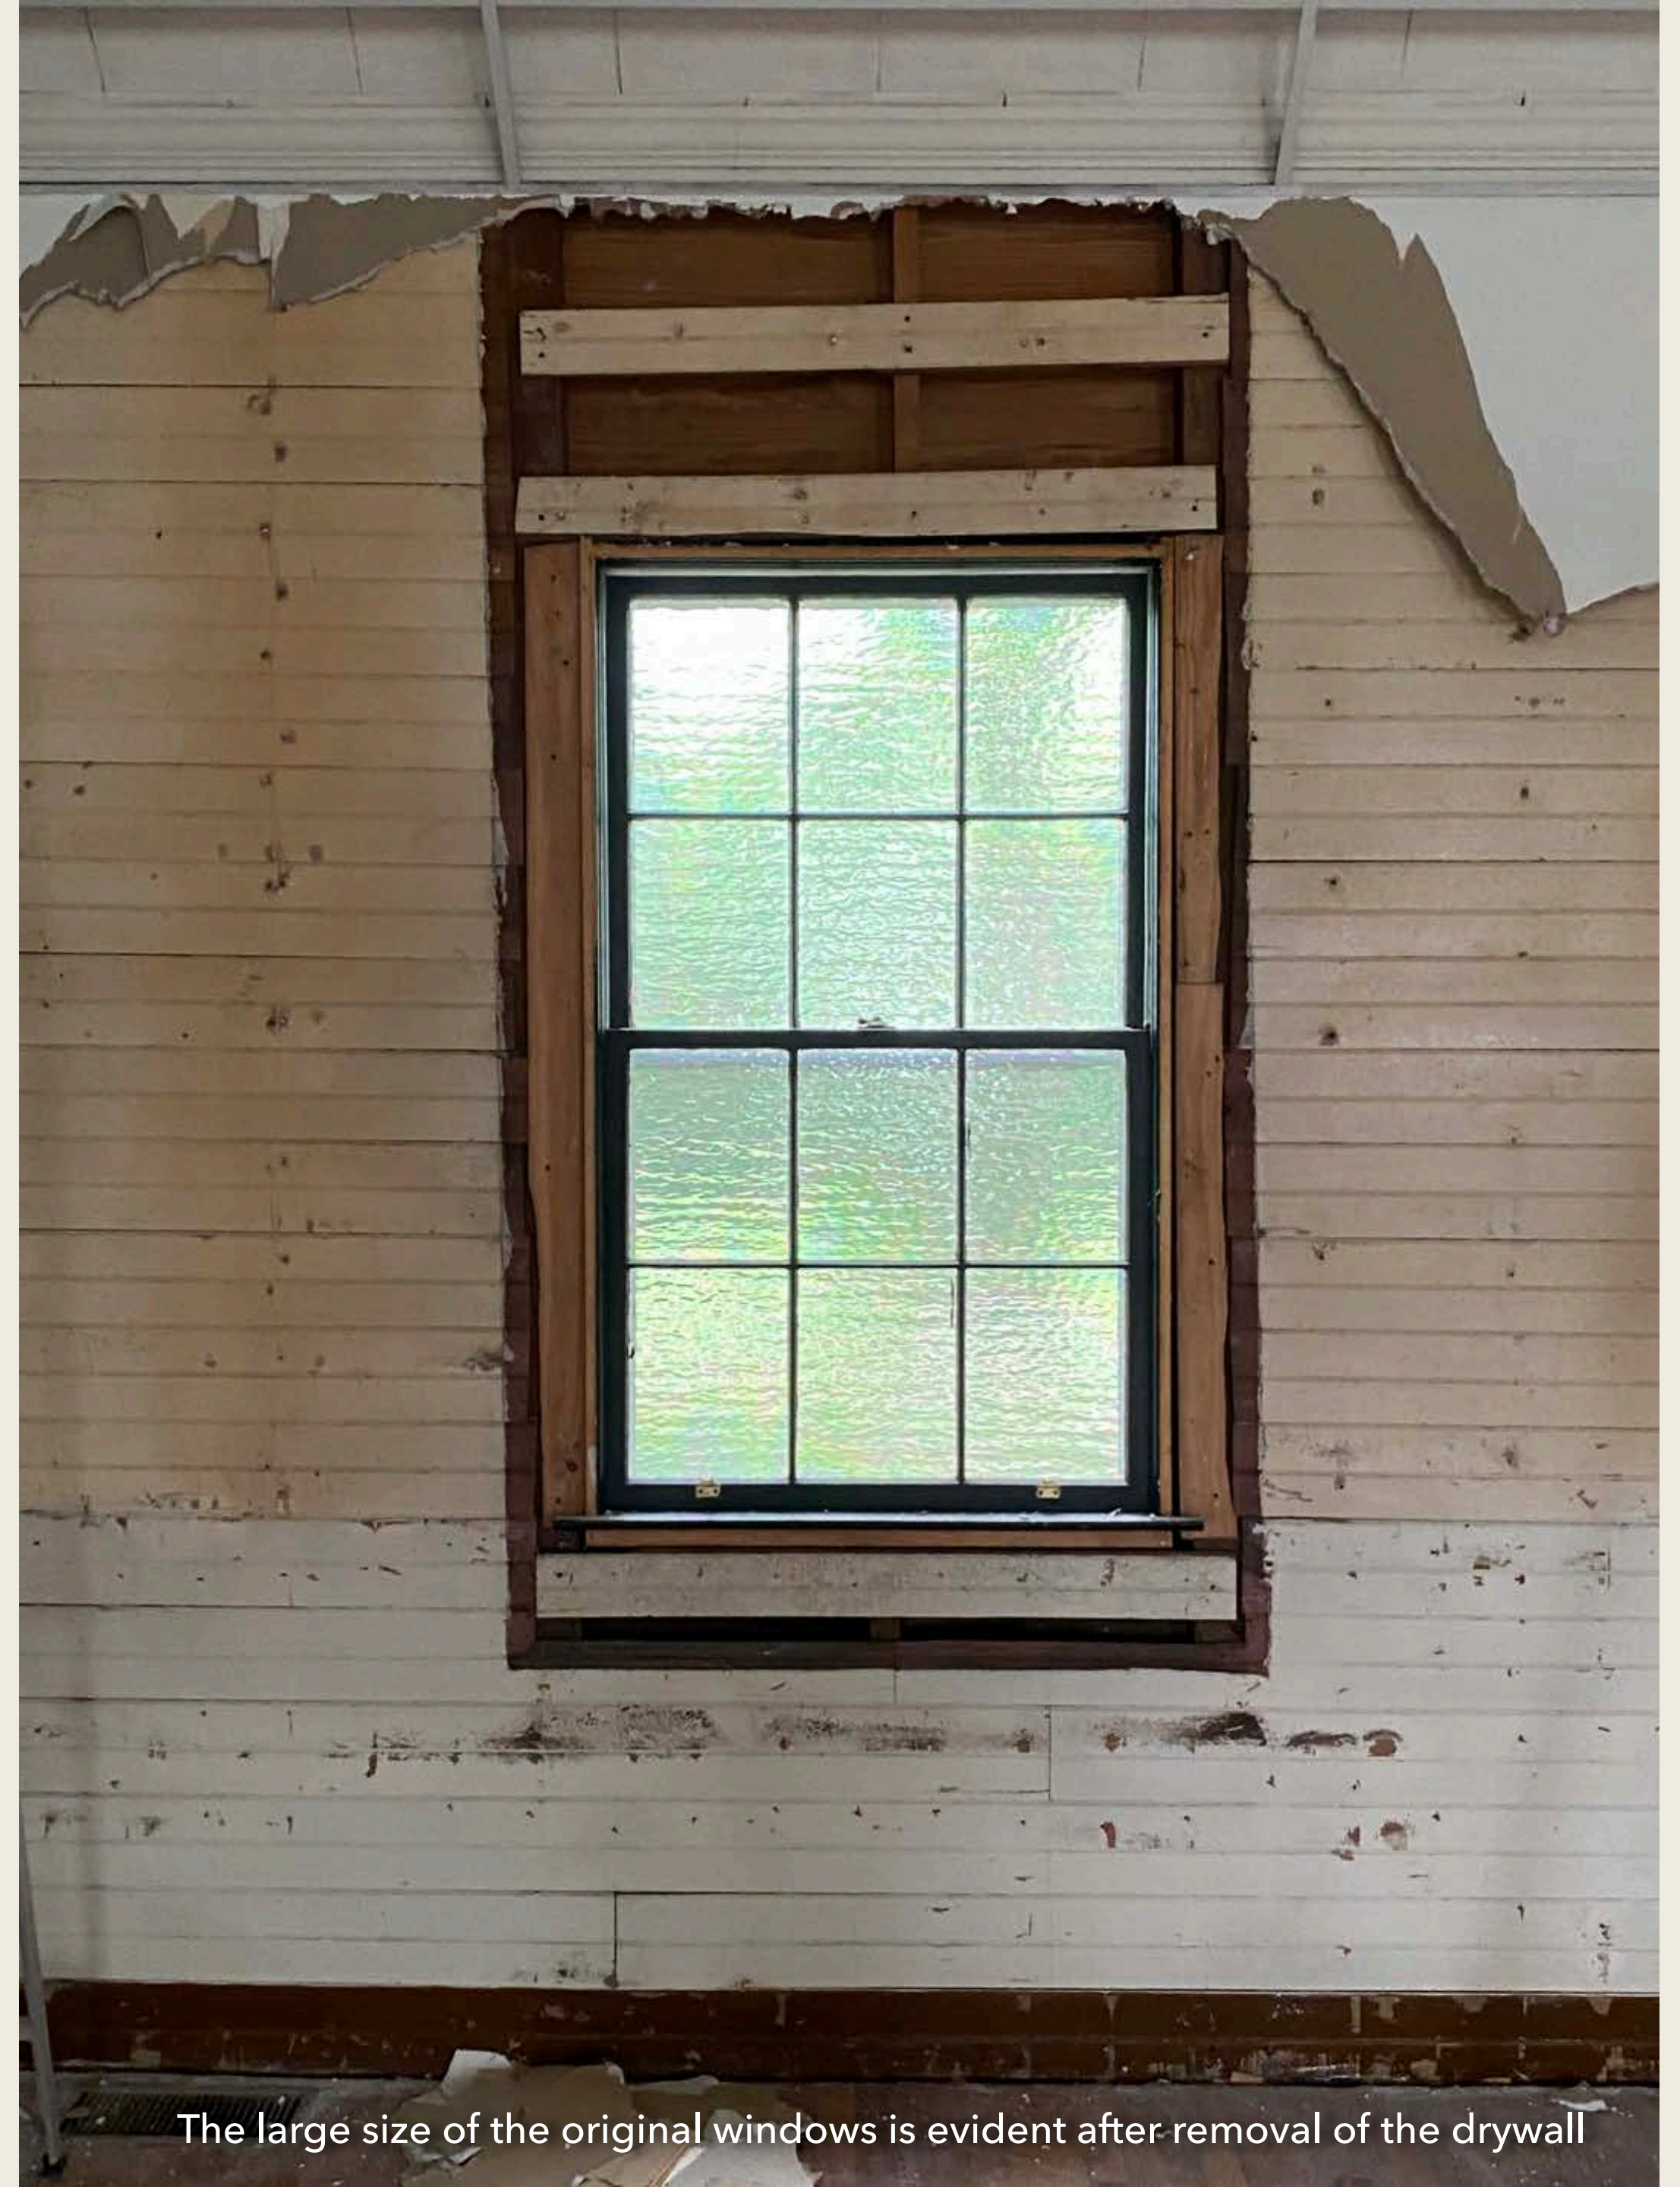
Current iridescent windows, likely from c.1963
