# Historic Woolsey Church

Resurrecting a local landmark

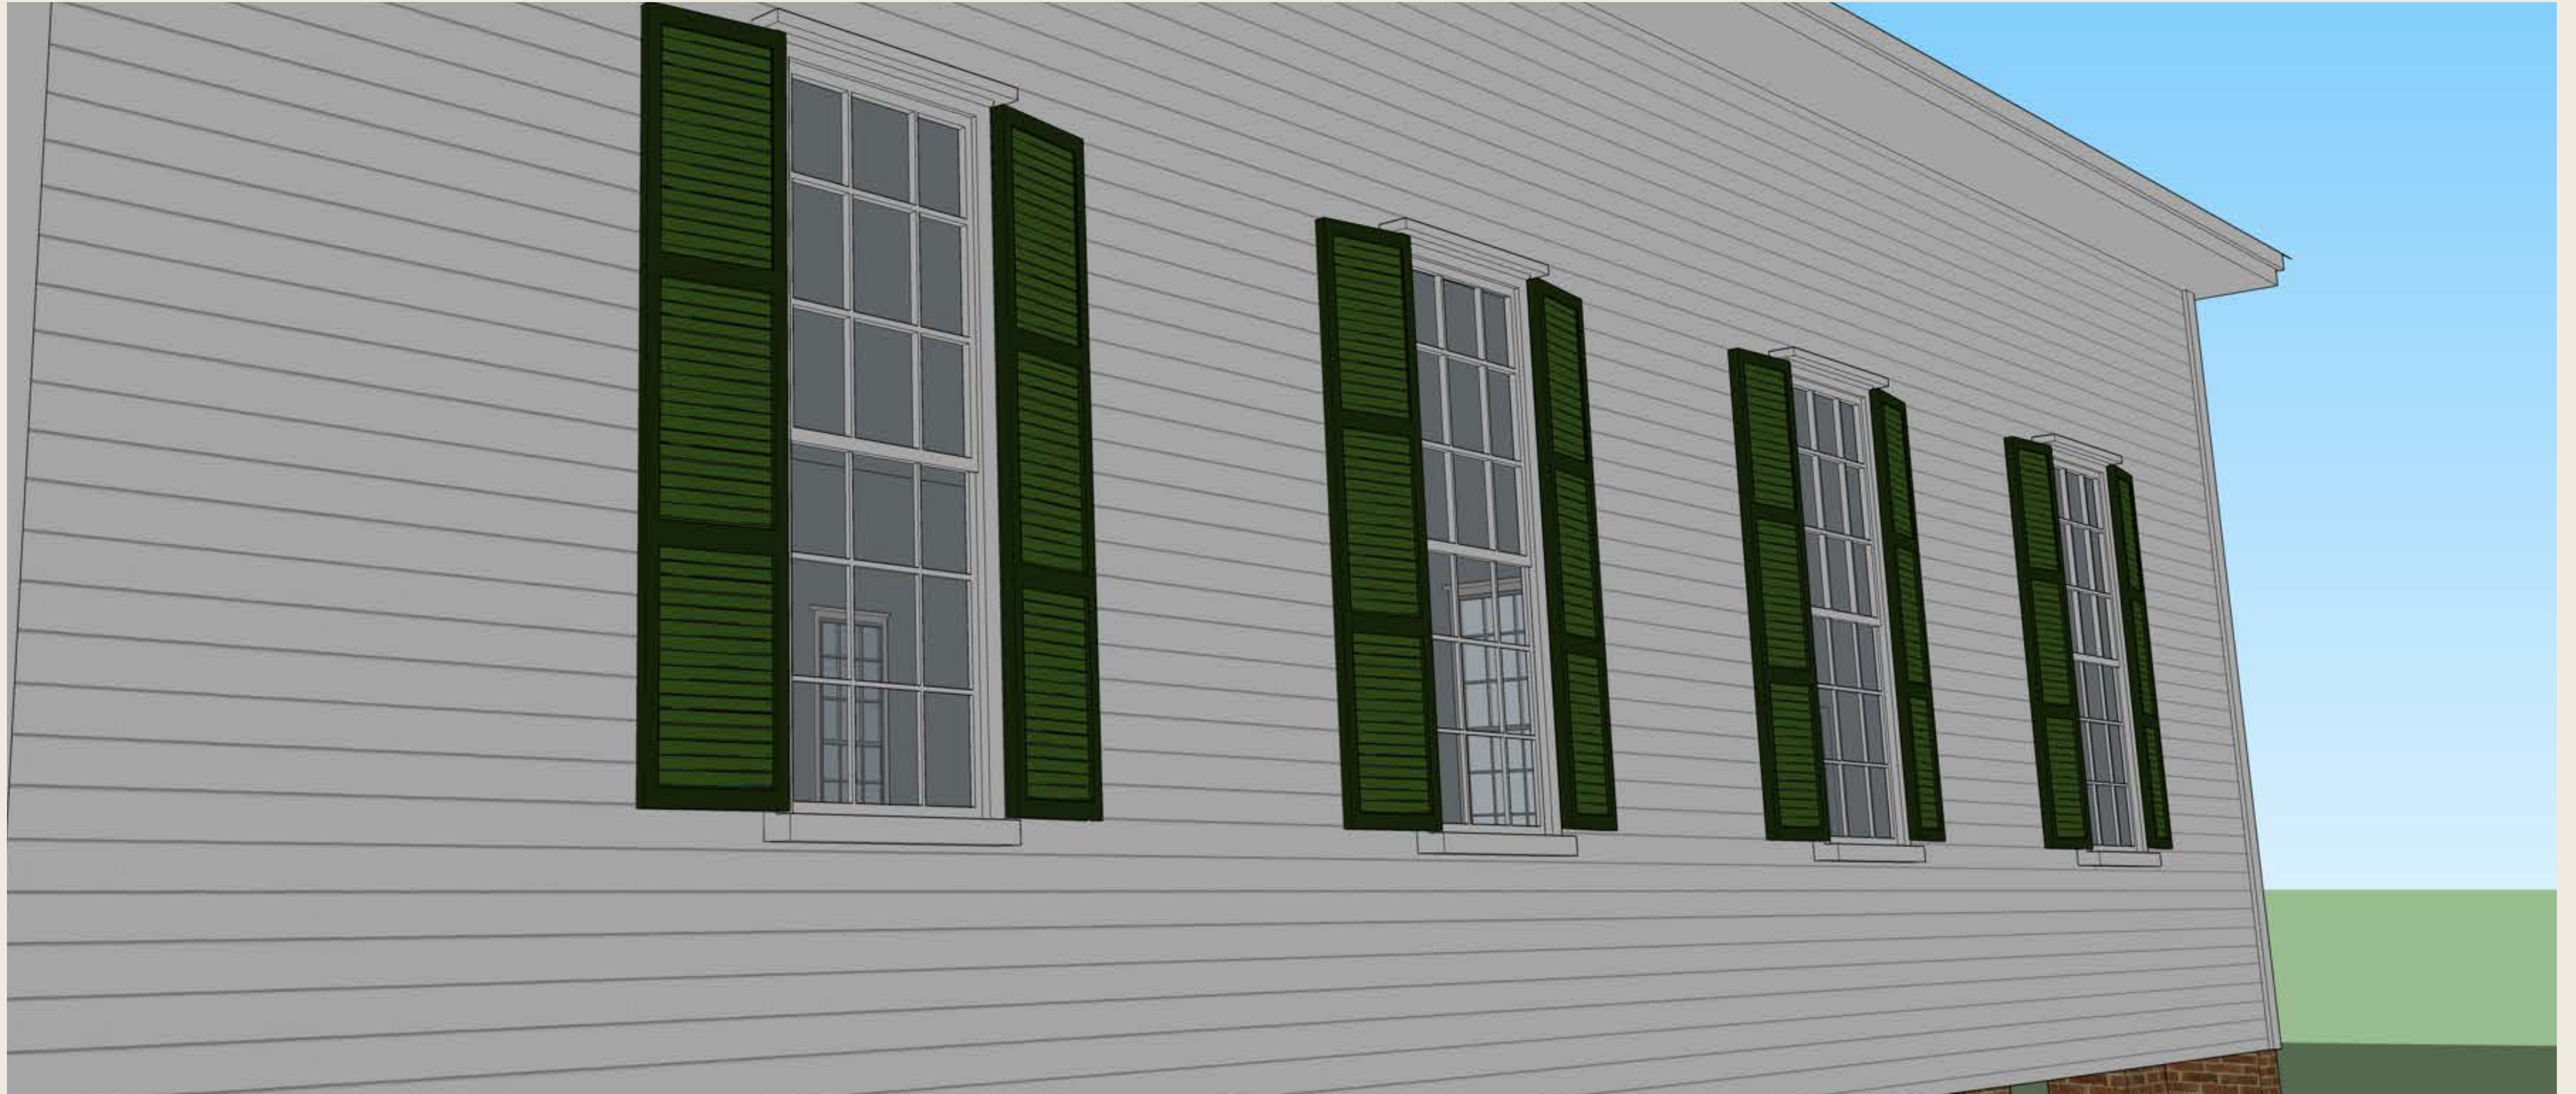
The original 9/9 windows are still extent in this mid-century image

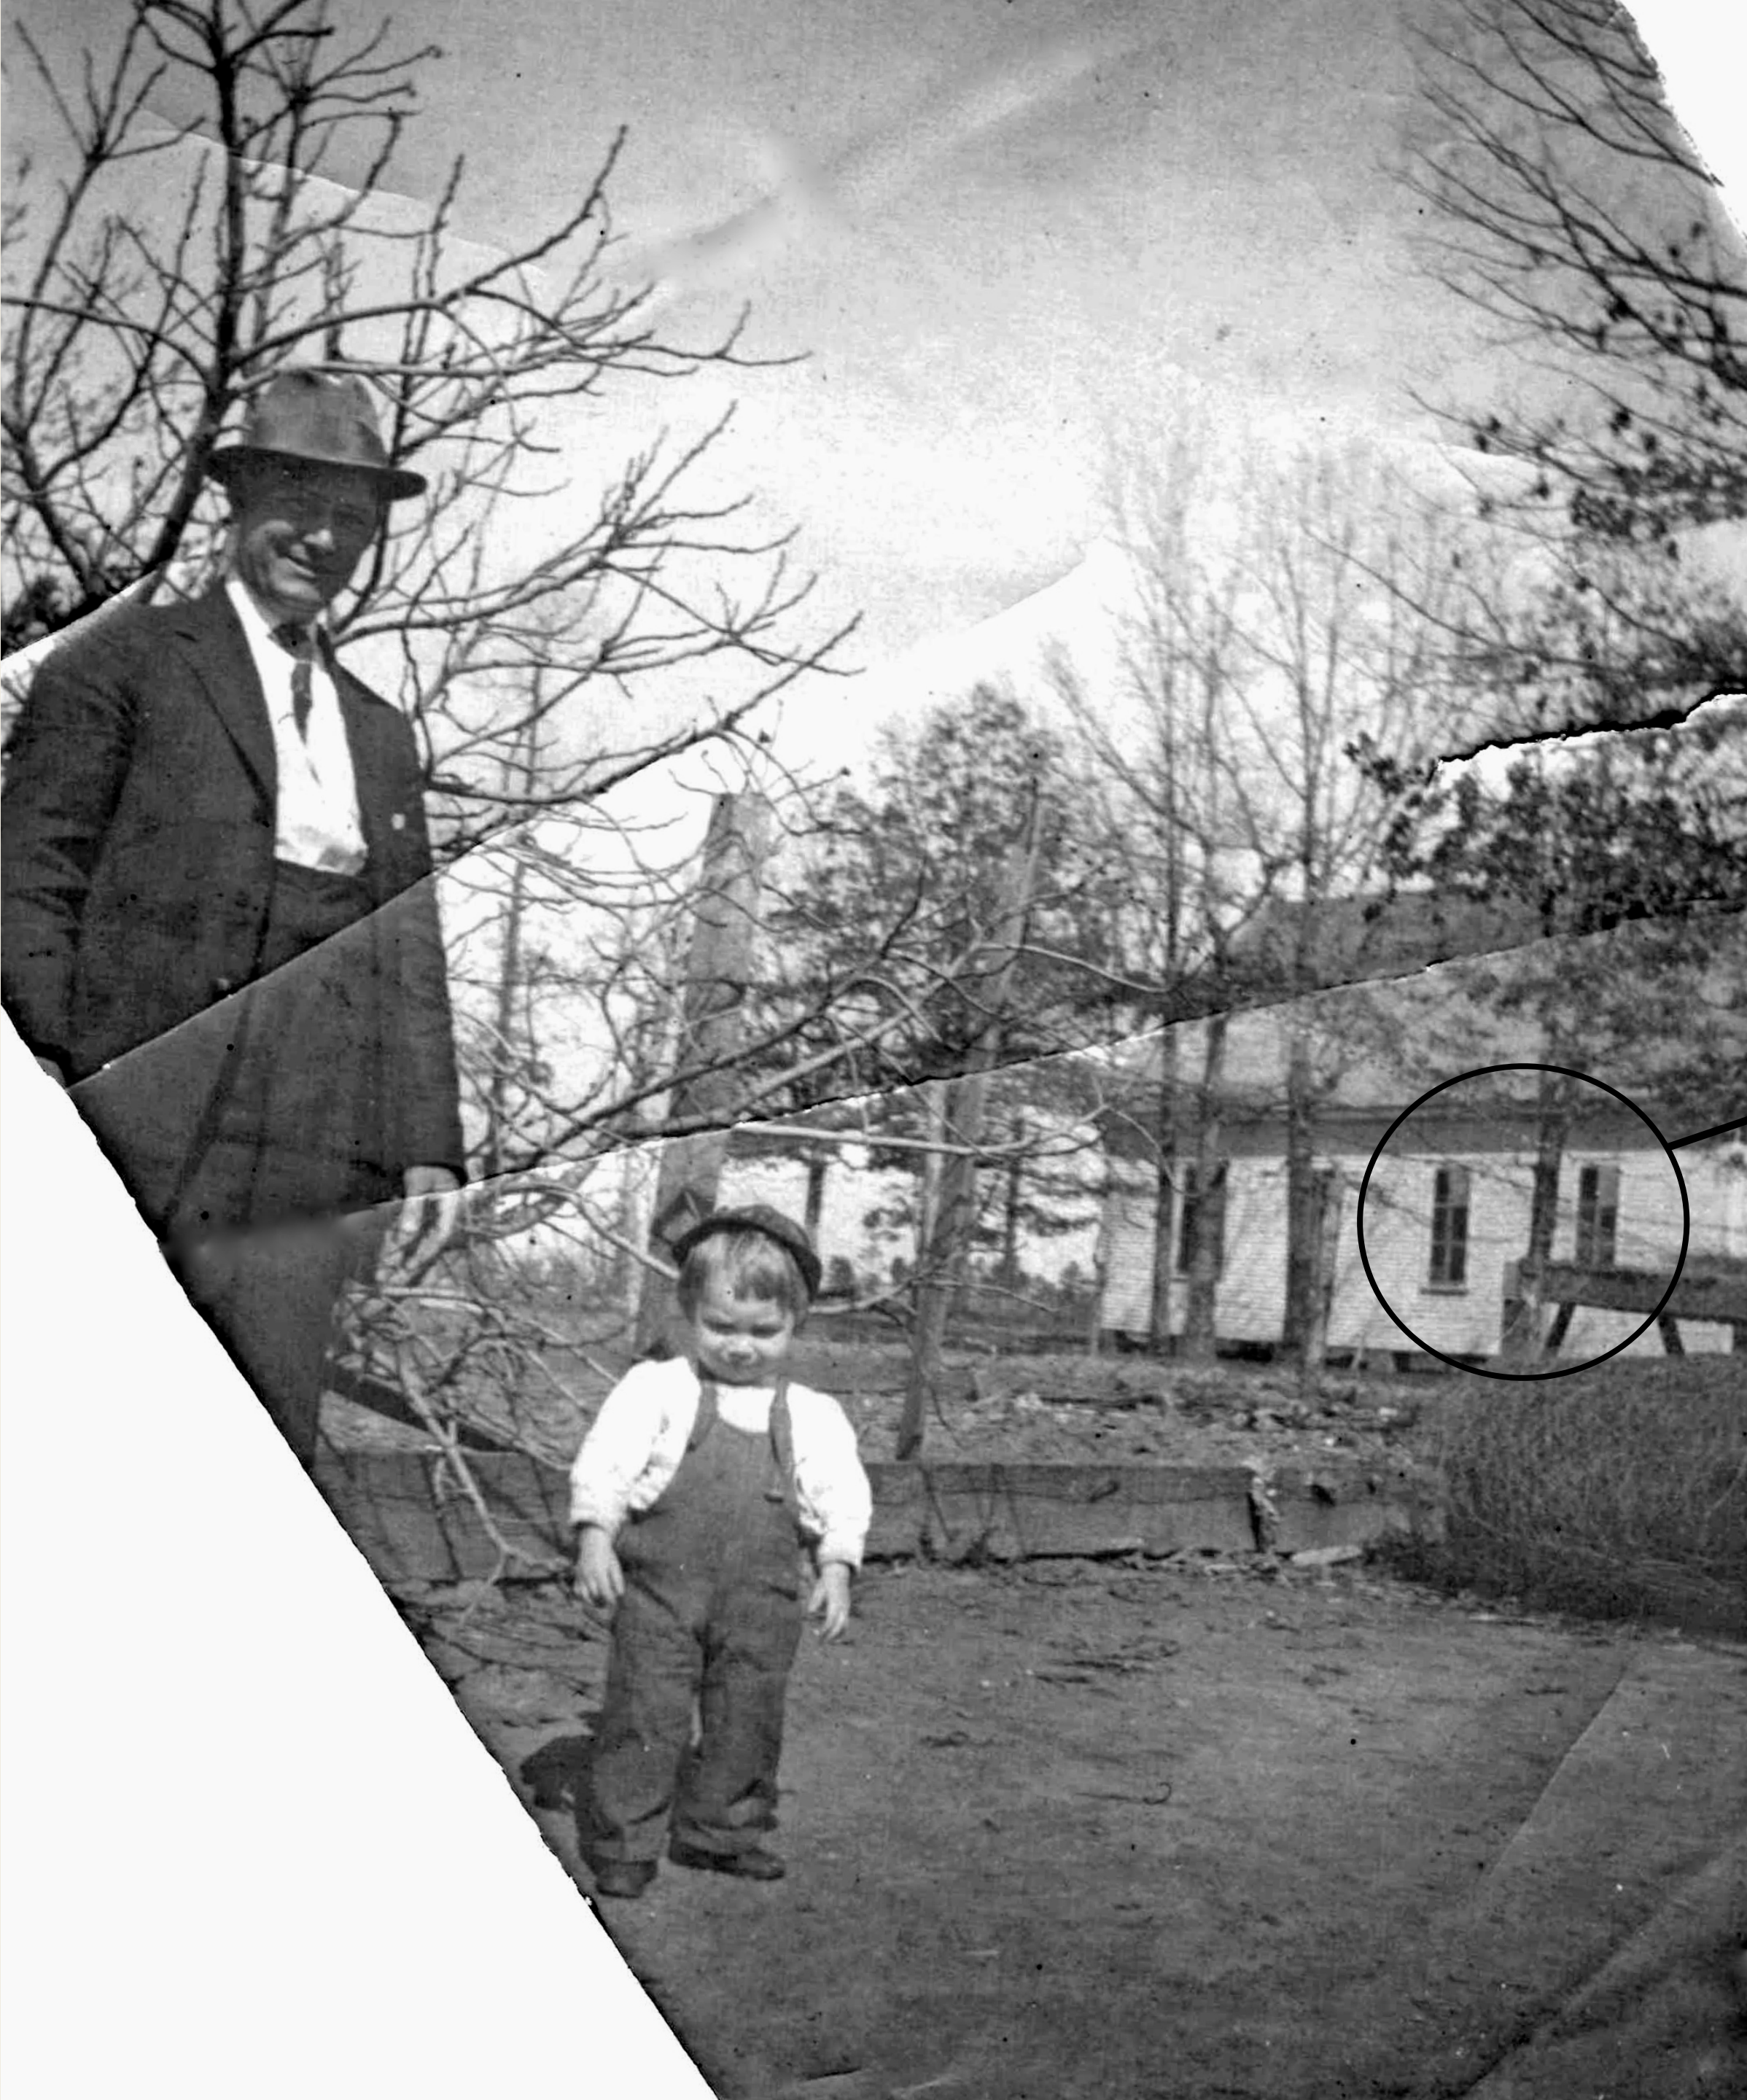
Shutters are proposed for reinstallation on the building

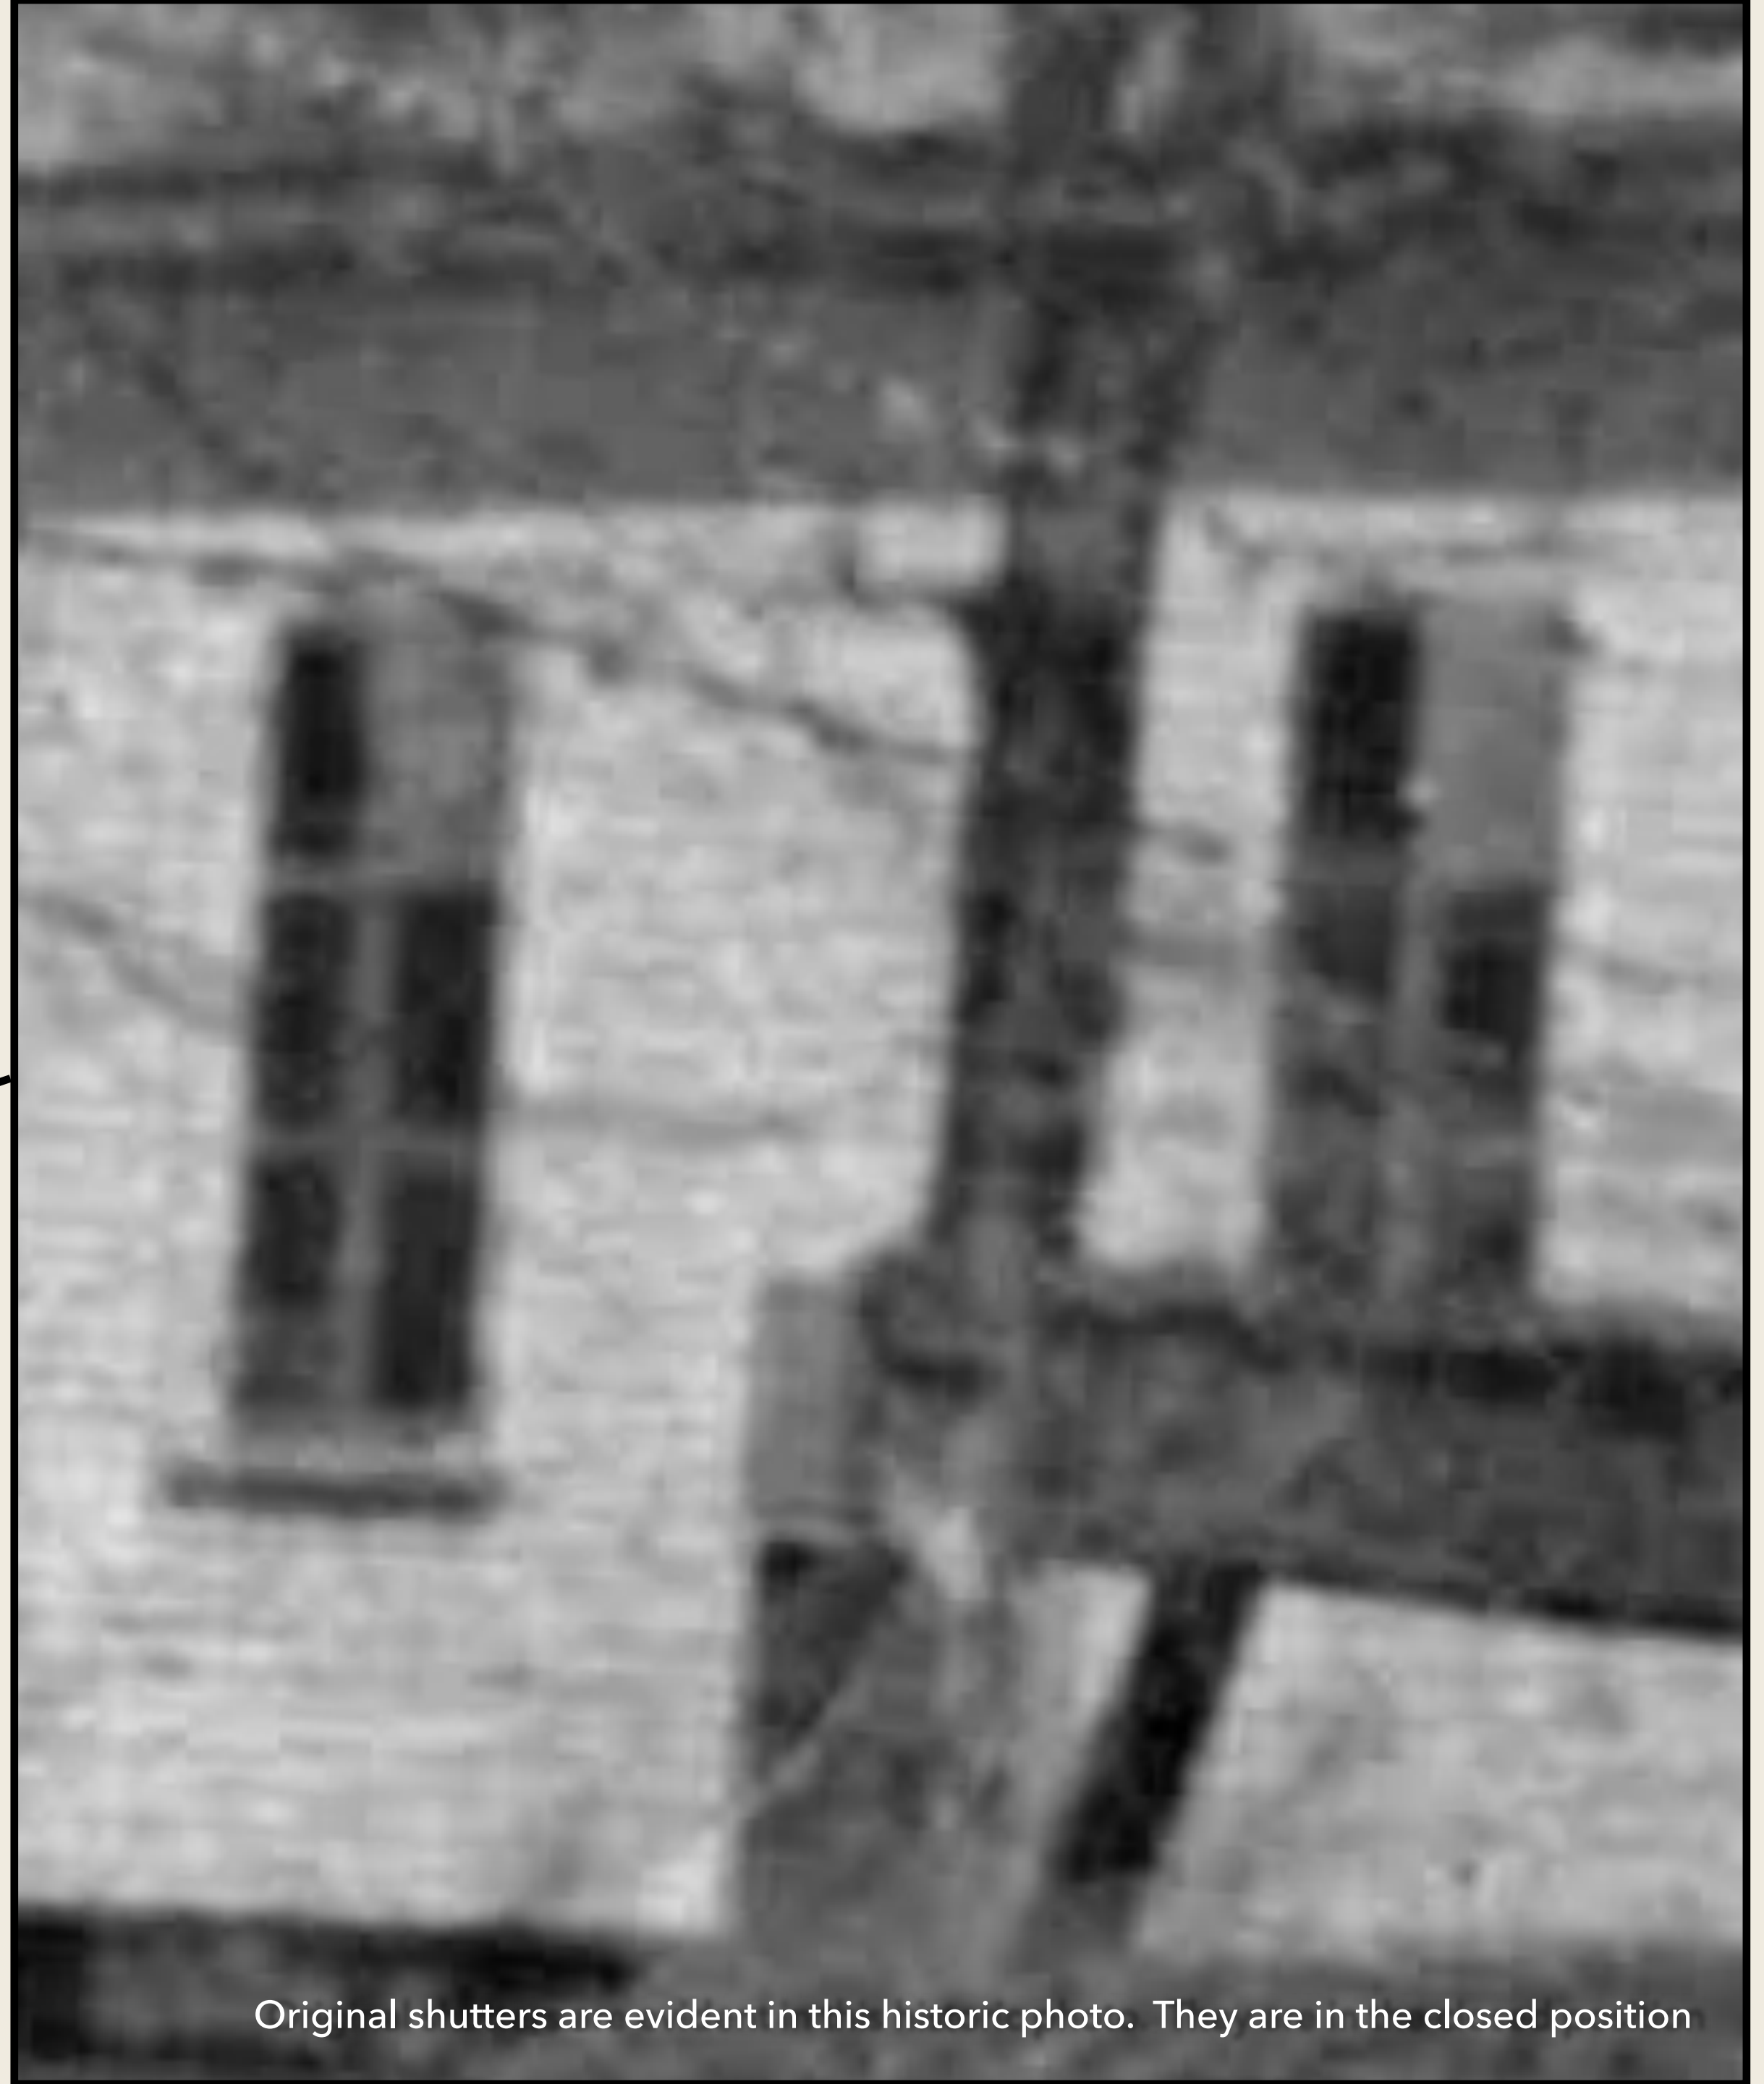
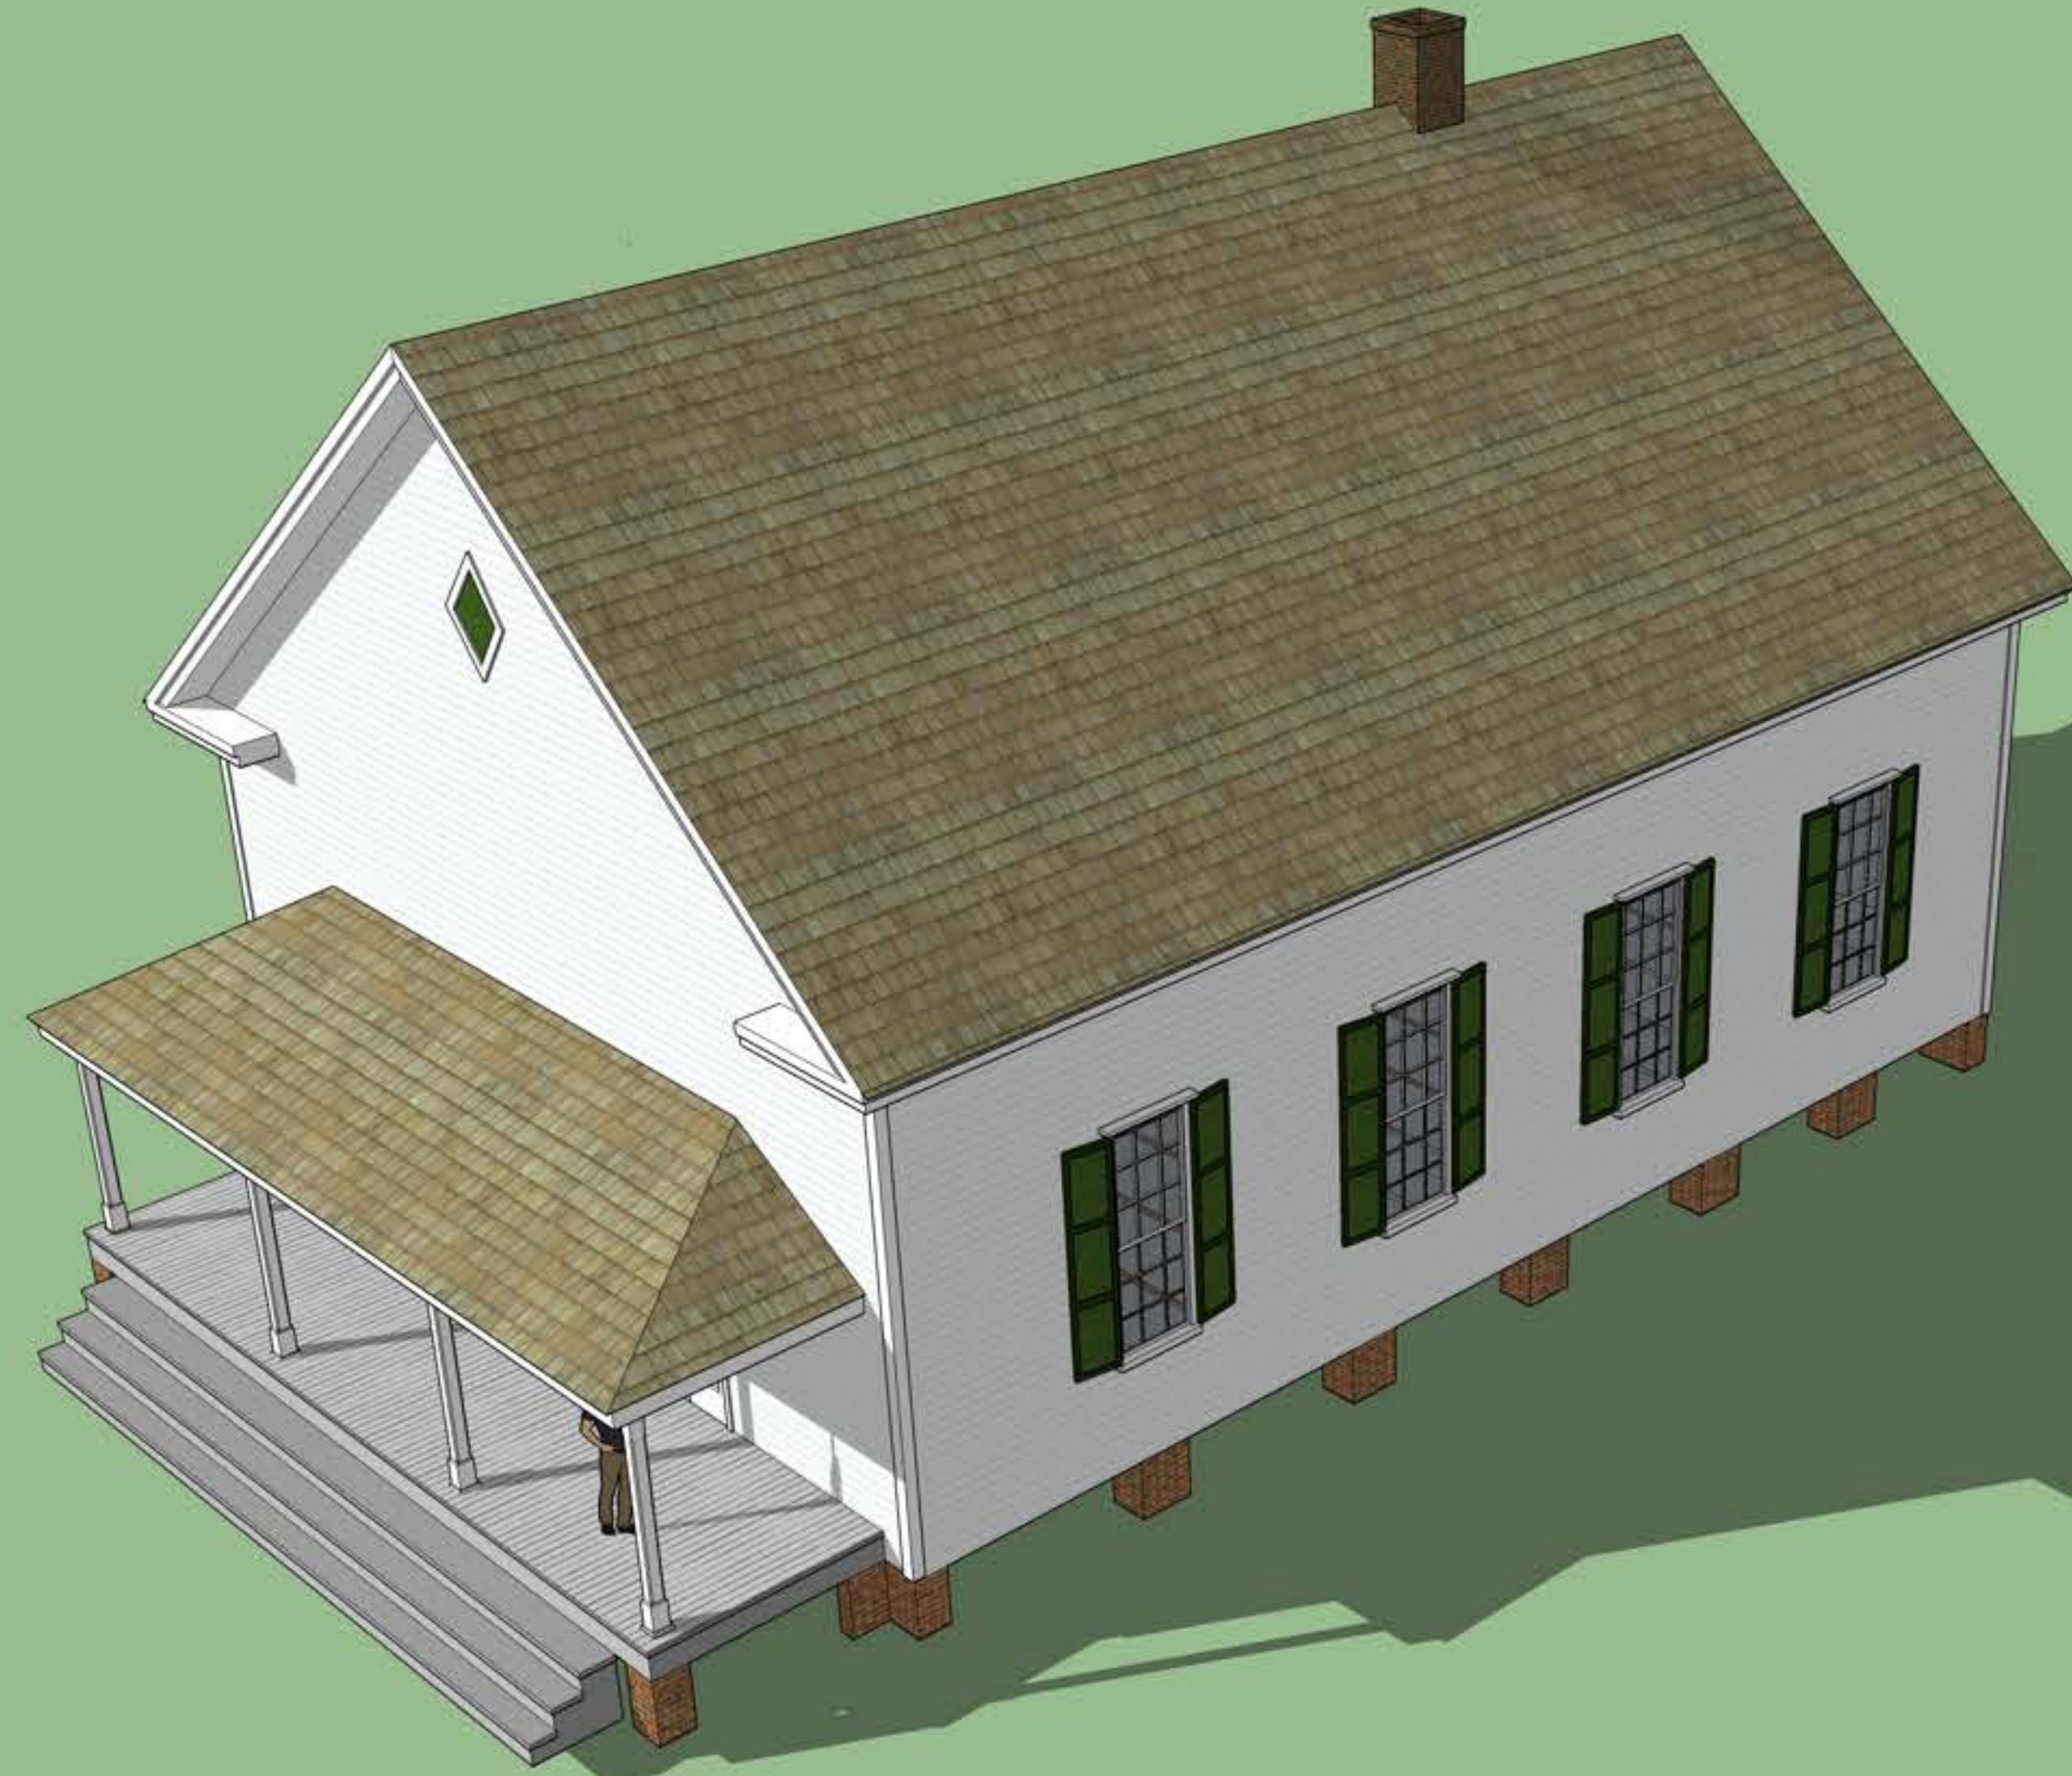
Original shutters are evident in this historic photo. They are in the closed position

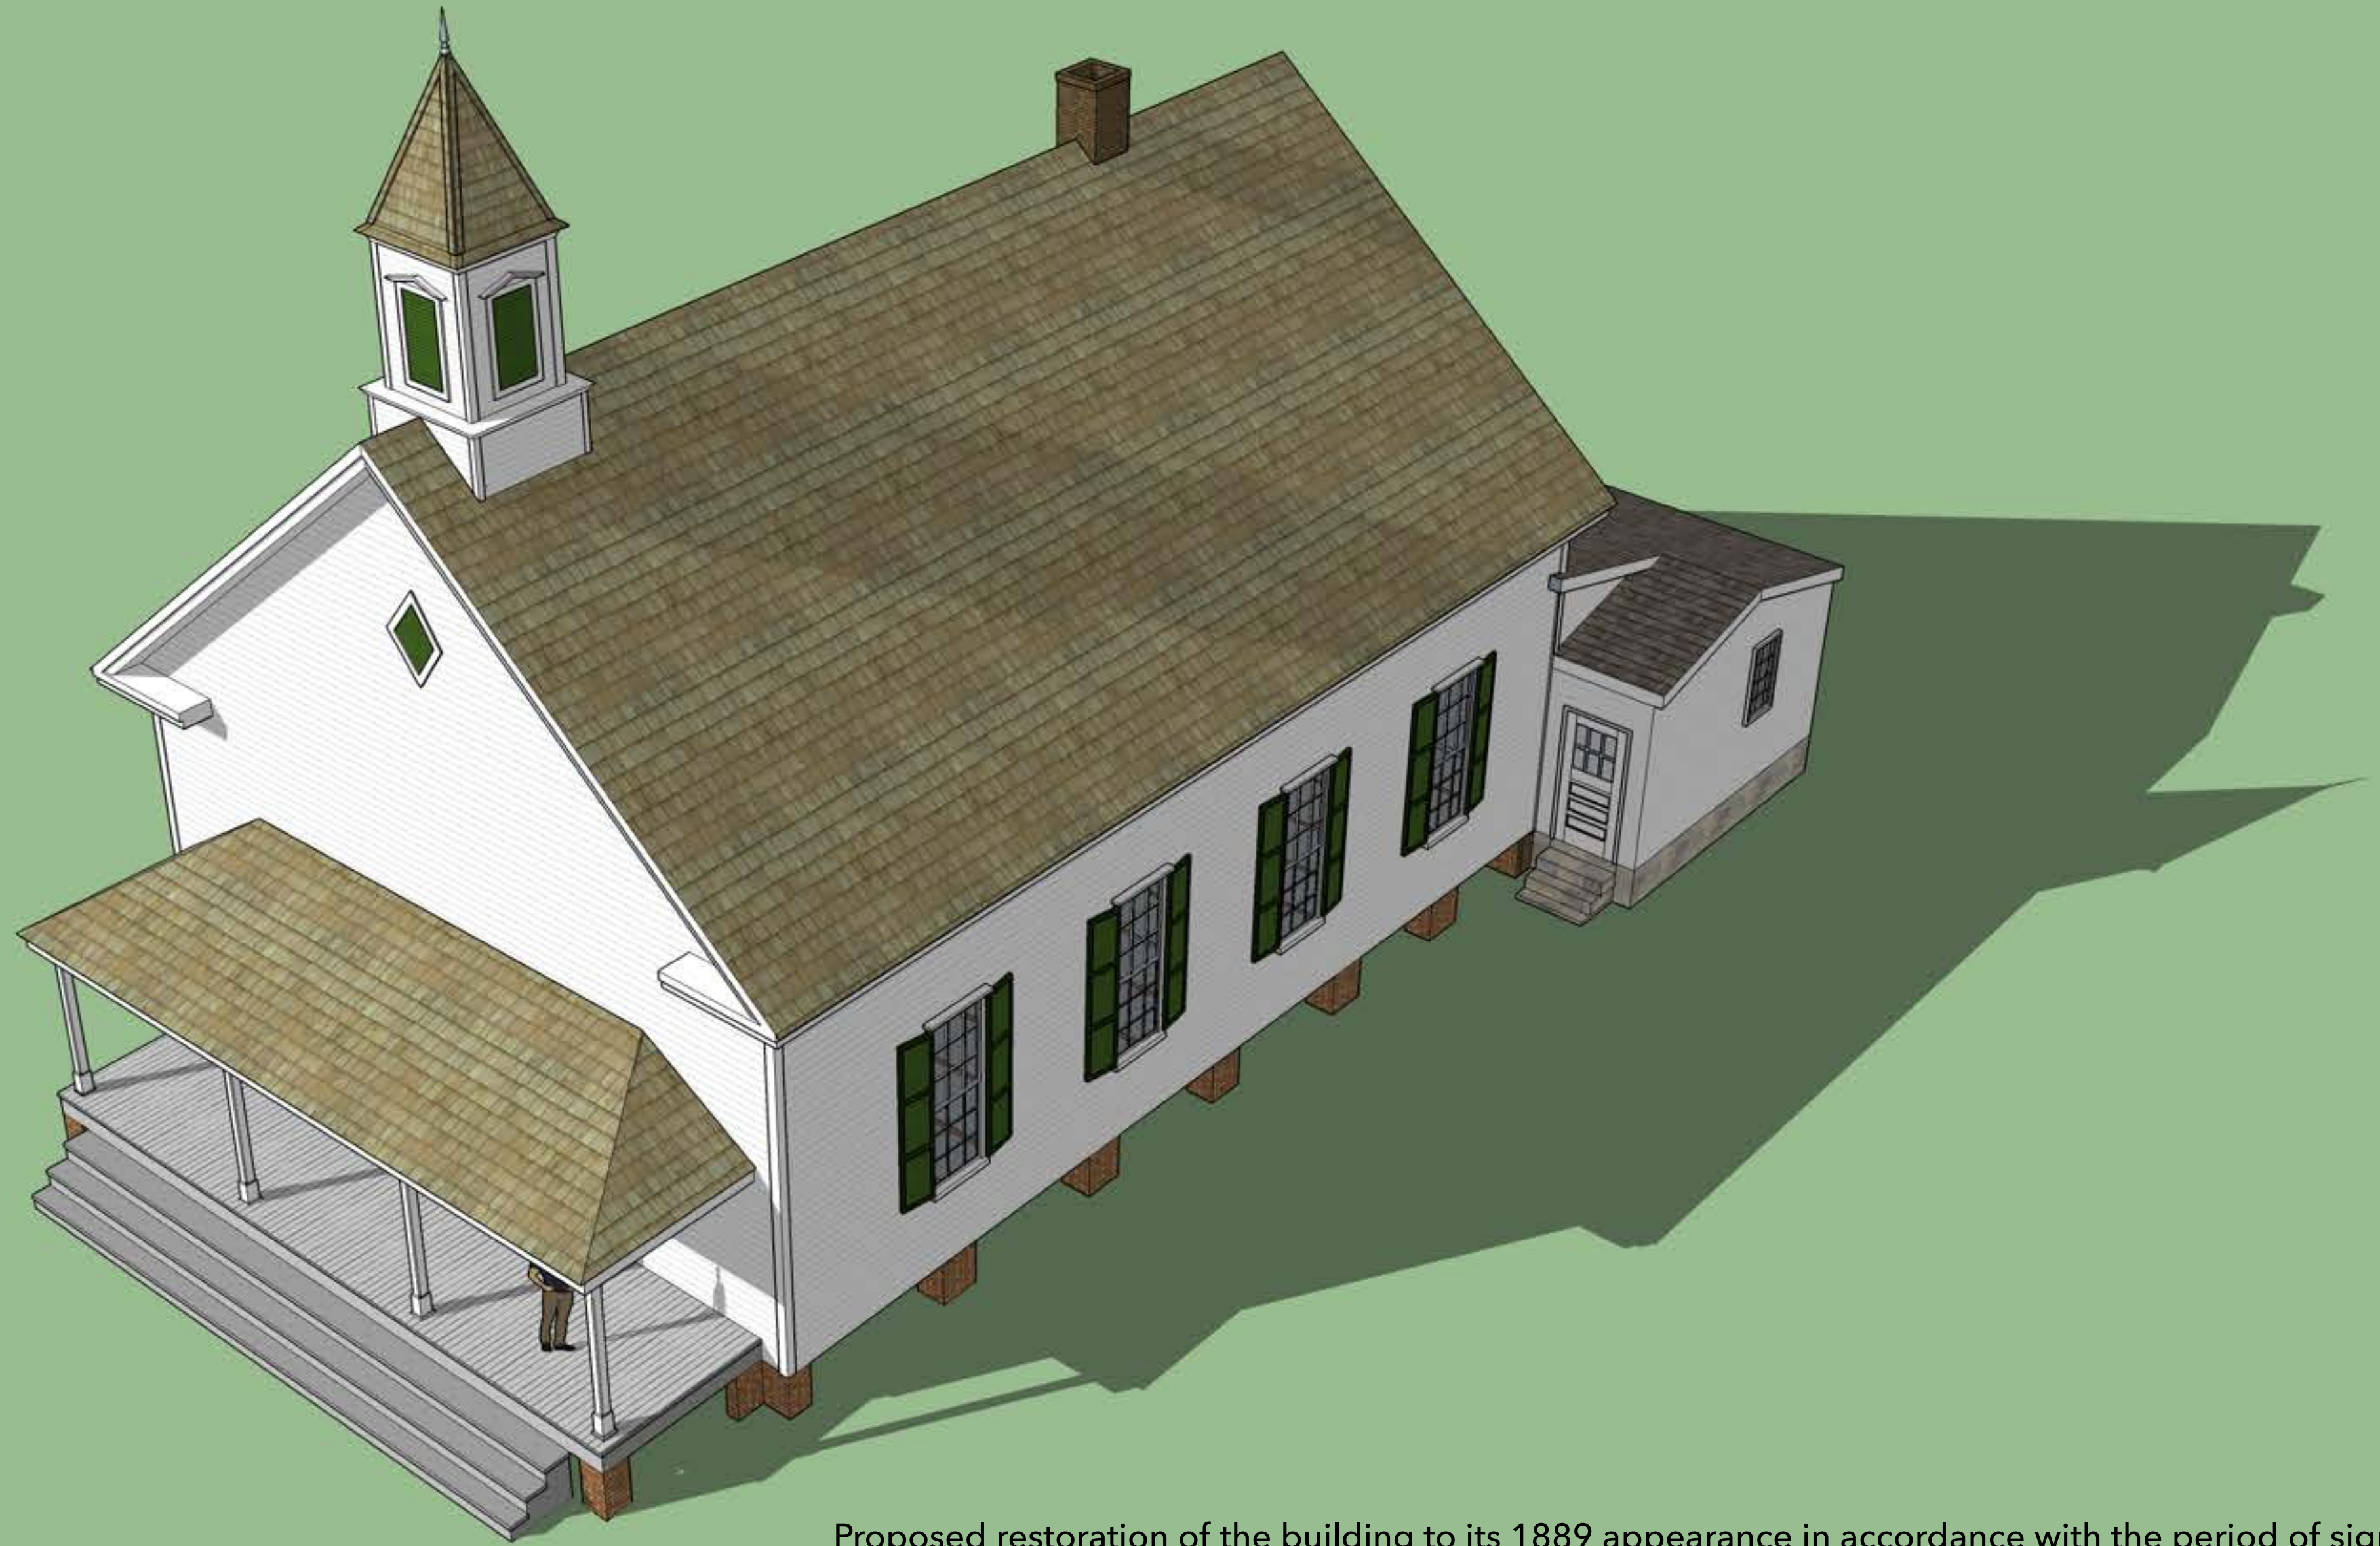
Proposed restoration of the front facade

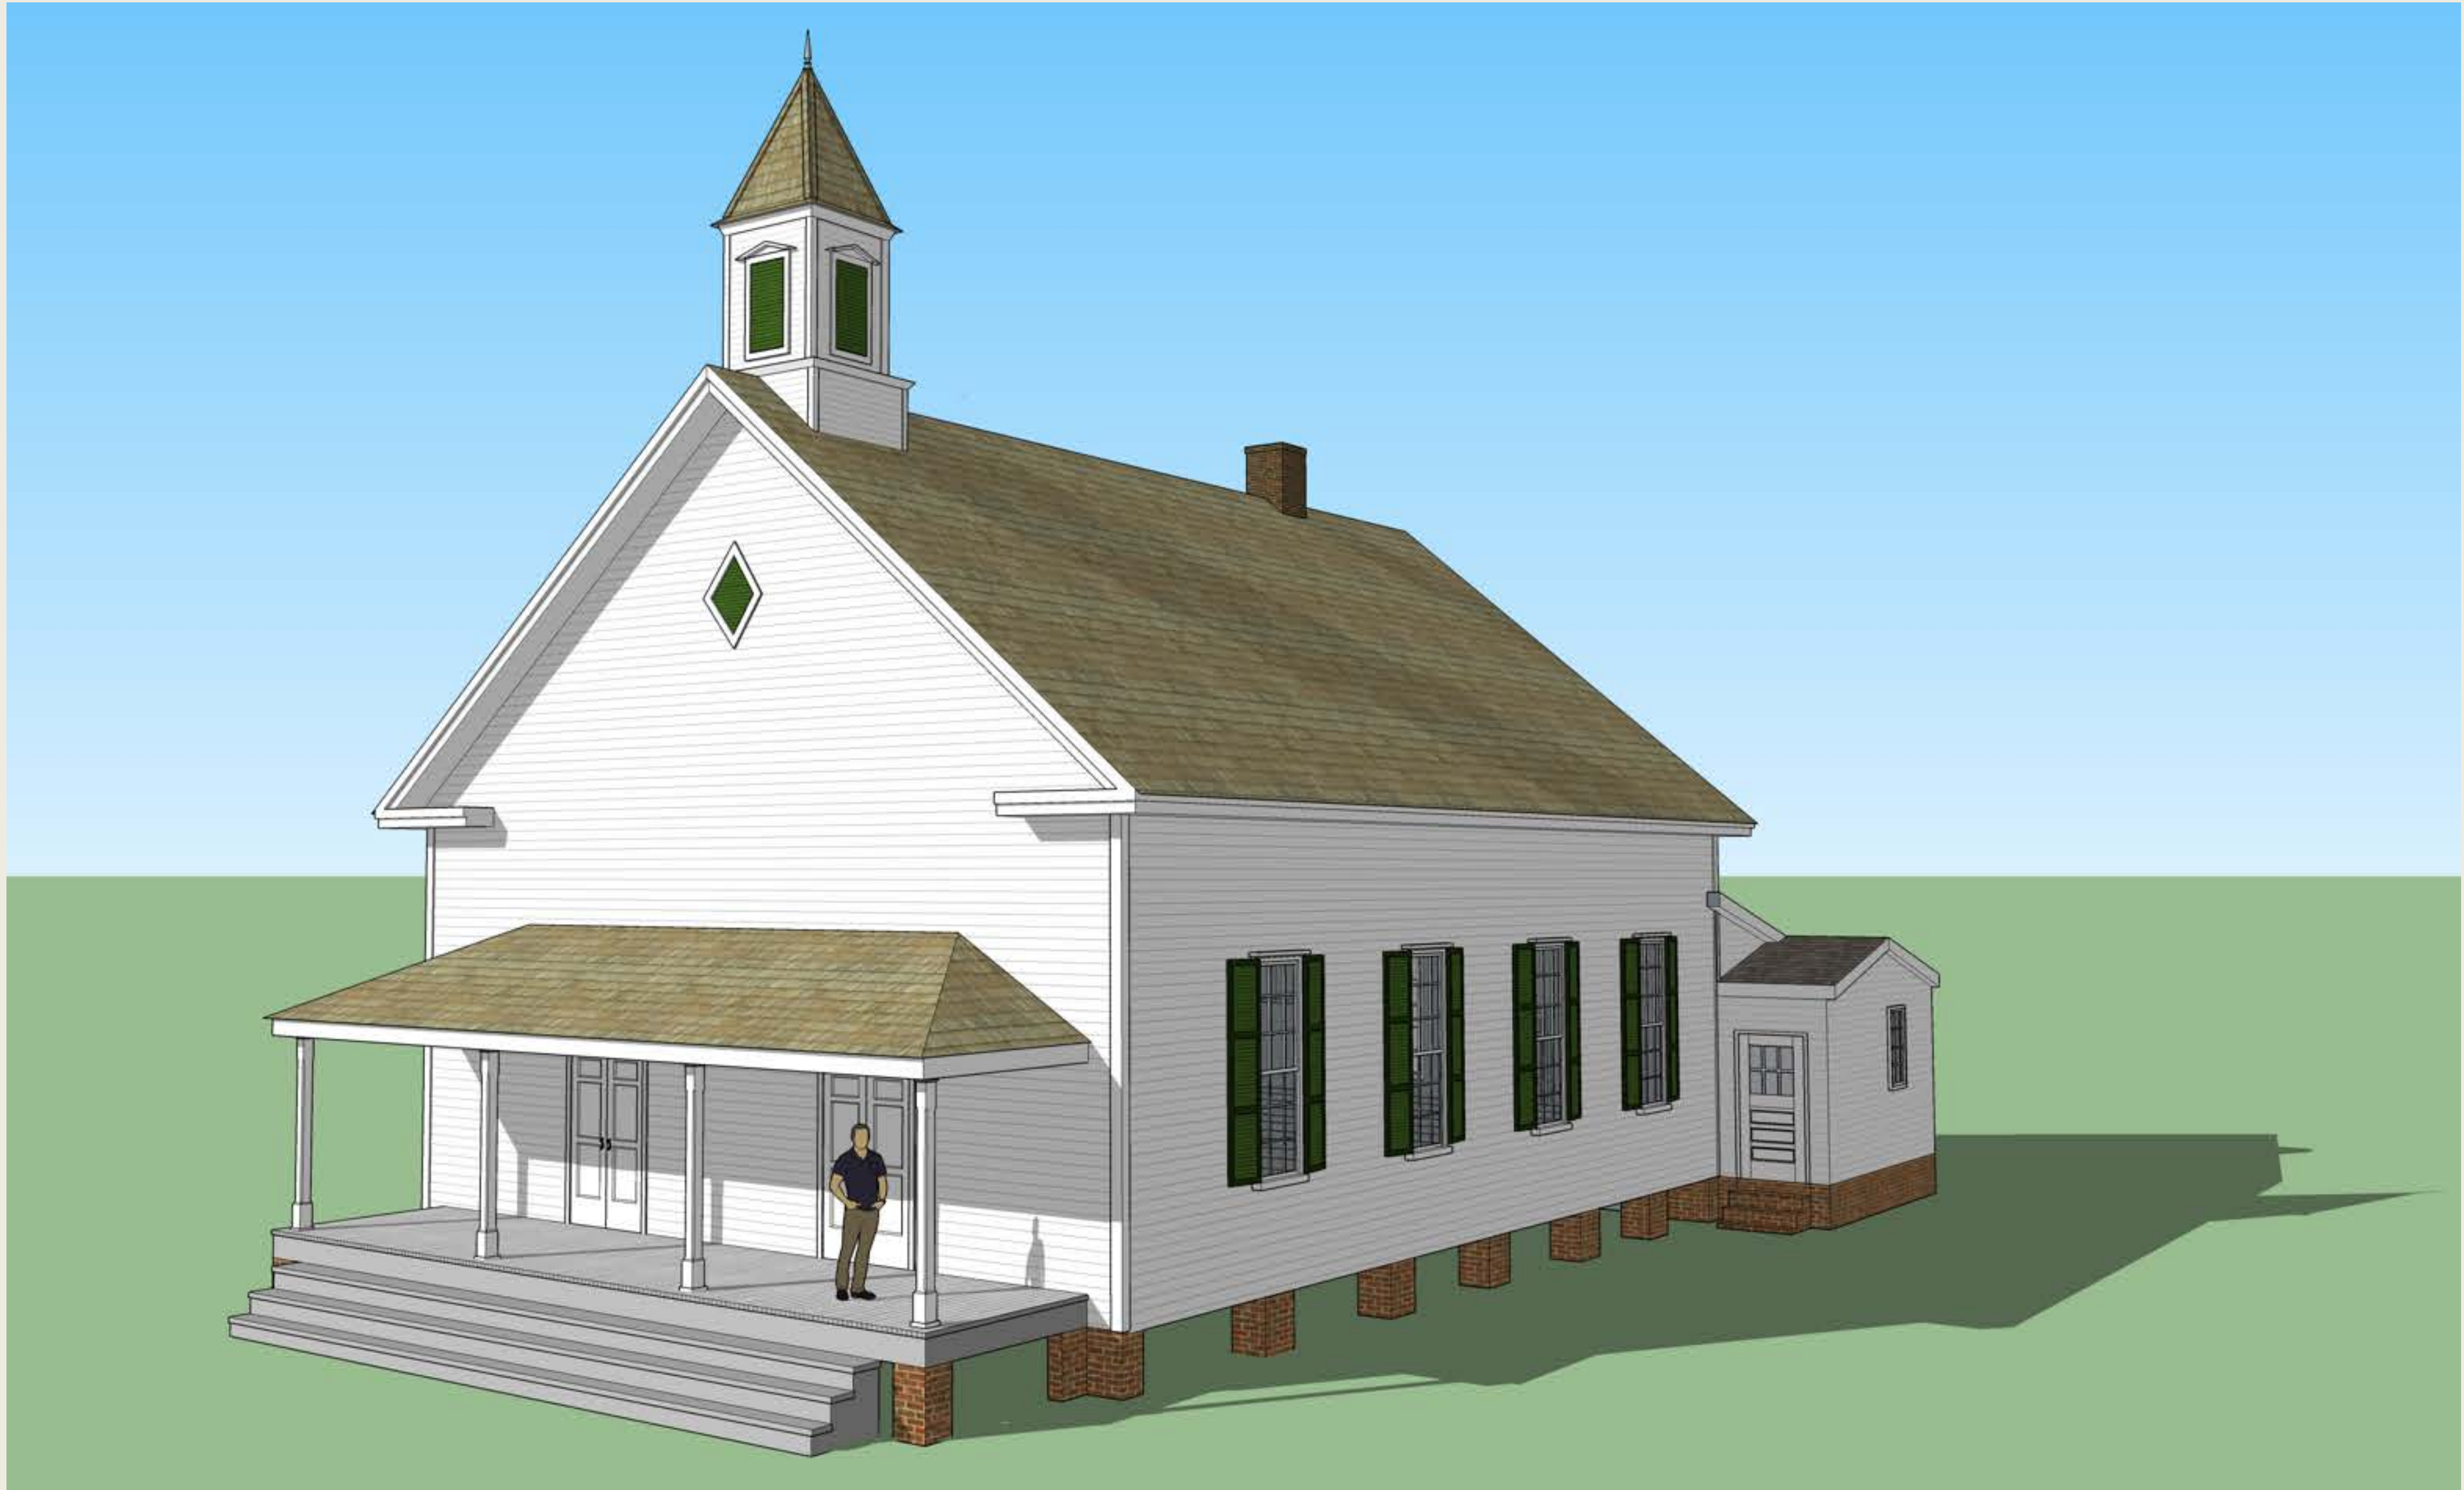
Proposed restoration of the building to its 1889 appearance in accordance with the period of significance.  
The existing classrooms on the rear of the building can remain to accommodate amenities such as ADA bathrooms, storage, and a dressing room.  
As an addition, it is subservient to the historic building and on a secondary facade.
